**RESEARCH INTO THE PERFORMANCE OF
WATER TANKS IN BUSHFIRE
-Bushfire CRC Project D1**

**R. Blanchi, J.E. Leonard, N. White, A. Sargeant, A. Bicknell, S Andersson
CSIRO – Sustainable Ecosystems (CSE)
Urban Systems Program**

USP2007/014

December 2007

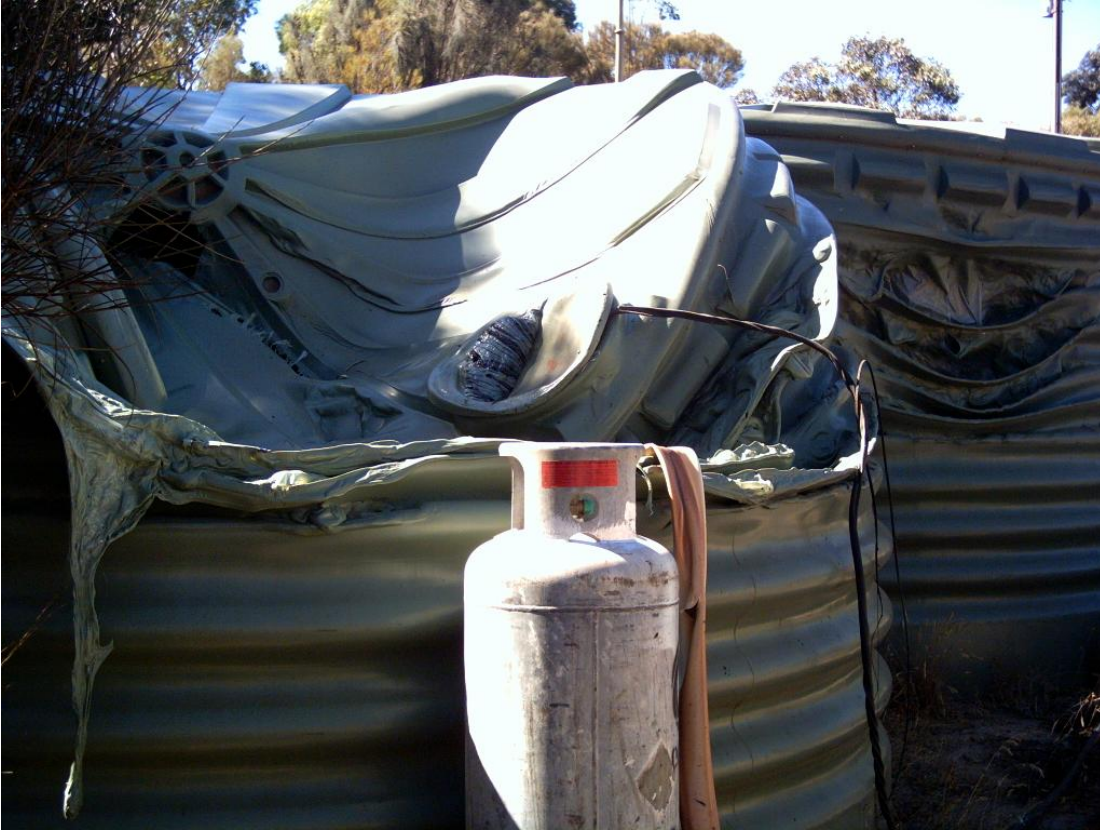
Figure 1 Example of water tank damaged, Eyre Peninsula

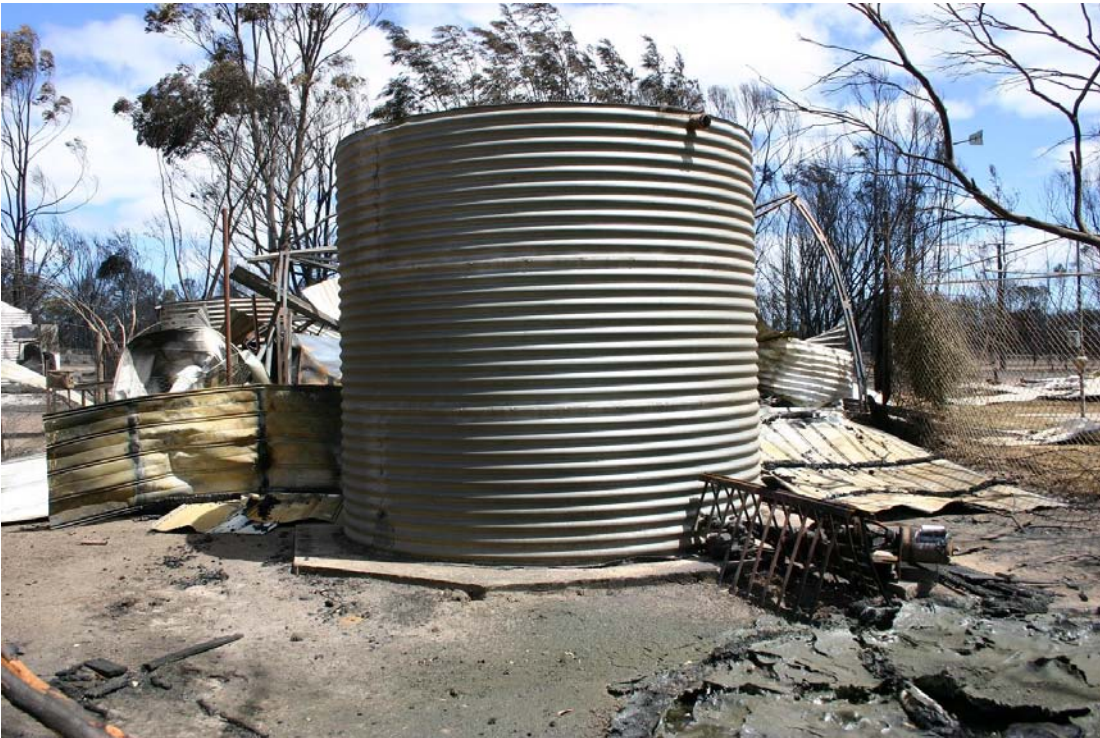
Figure 2 Example of metal water tank withstanding adjacent structure fire, Eyre Peninsula.

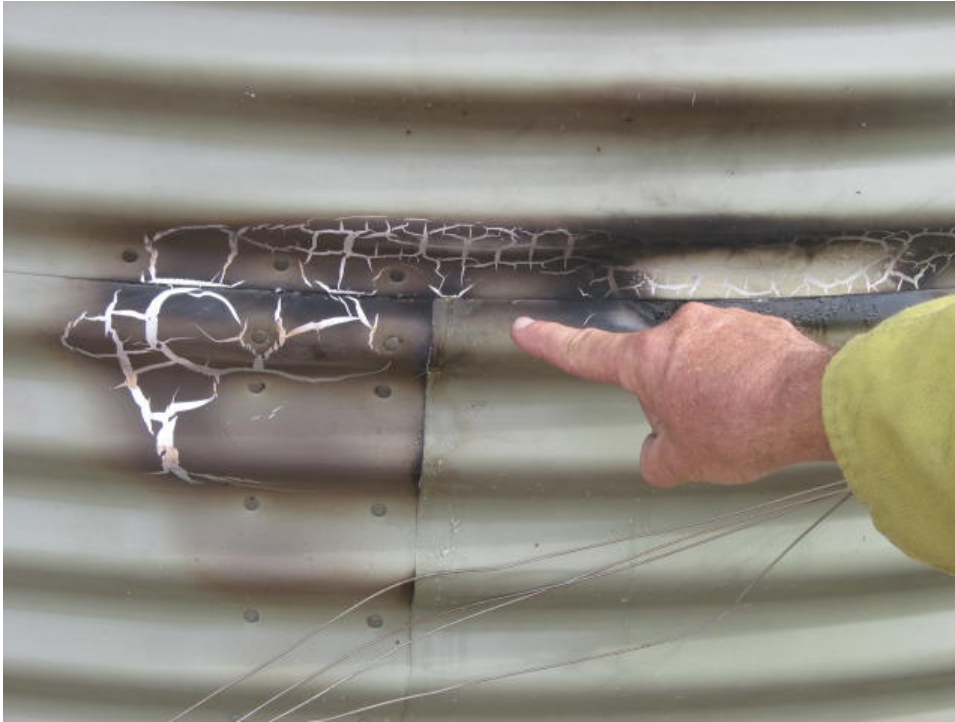
The surface of the tank shows heat effected regions below the waterline where silicone mastic was used to seal metal panel intersections. There are small leaks from some of these seams (see Figure 6). However the rate of leakage was very slow. Front surface temperatures in this region were in excess of 280°C.

Figure 6 Experiment 2 - Leaf litter ignited and flame immersion exposure, small leaks from the seams

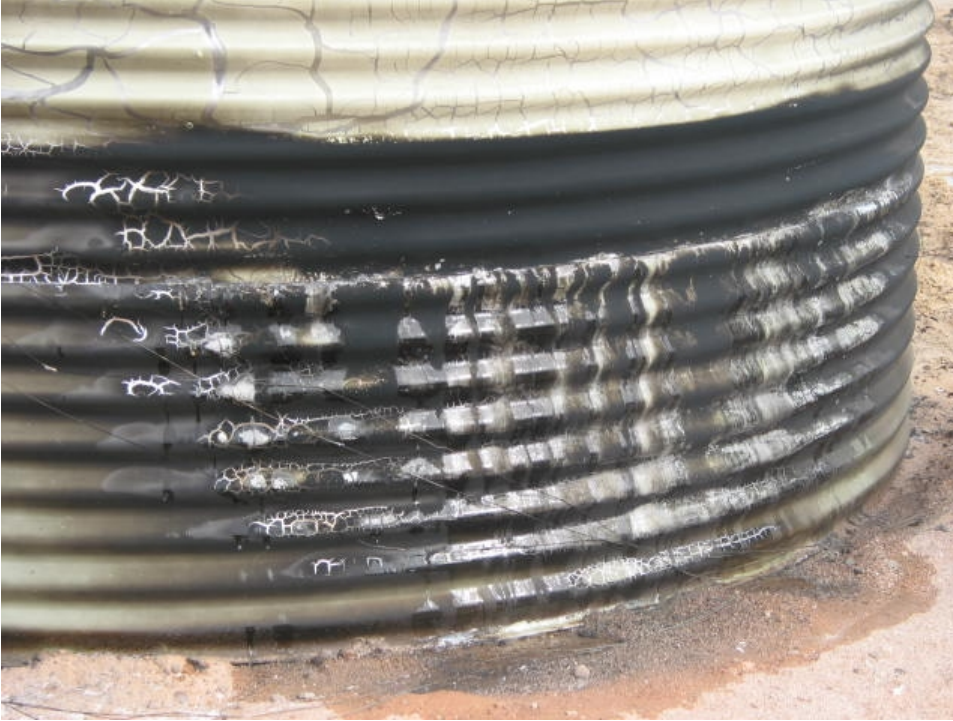
The front face of the tank became heat affected; the paint is burnt and cracked (see Figure 7). The leaking from the seams has increased and is less than 2 litres per minute.

Figure 7 Experiment 3 - Structure exposure on metal coated tank

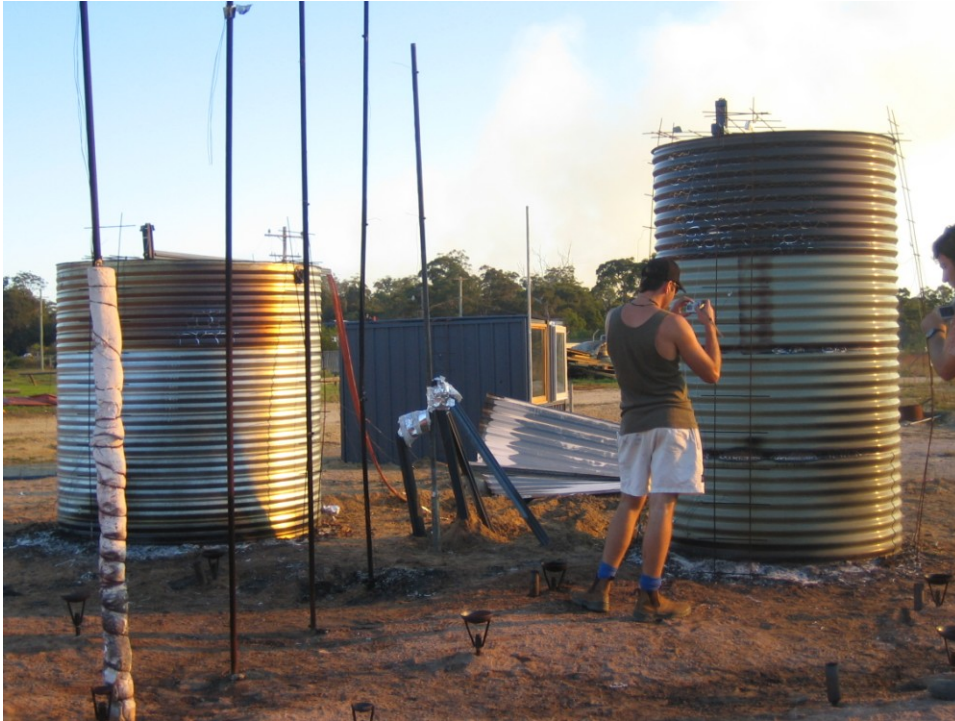
Tank 5 is blackened above the waterline but show signs of leakage (see Figure 14).

Figure 14 Experiment 9 - Pre-radiation and flame exposure on metal tank

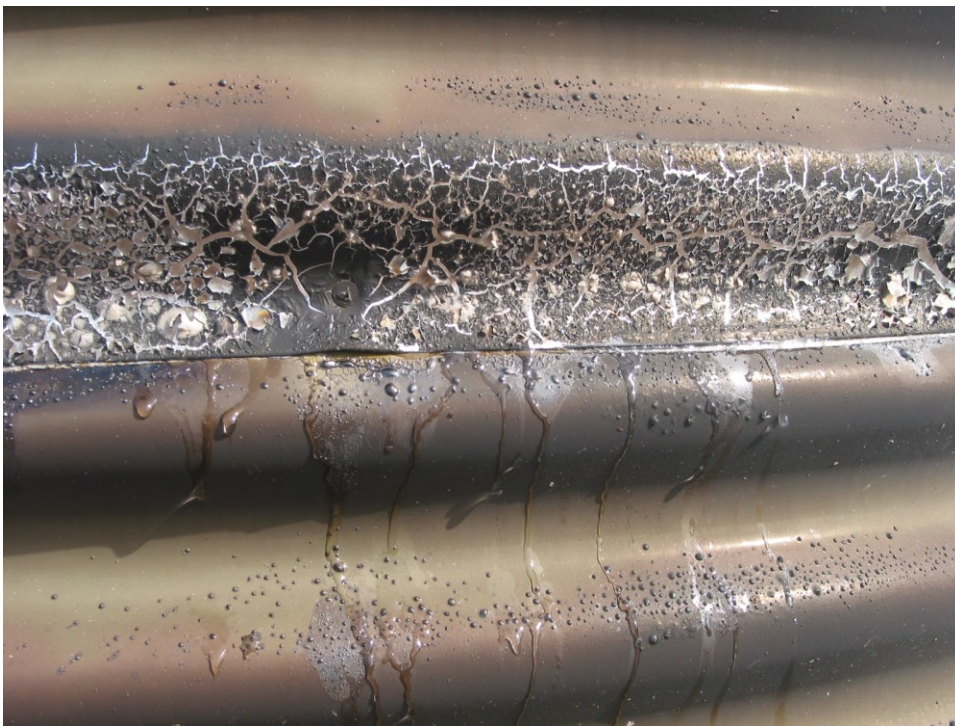
Figure 15 Experiment 9 - Leak from seams

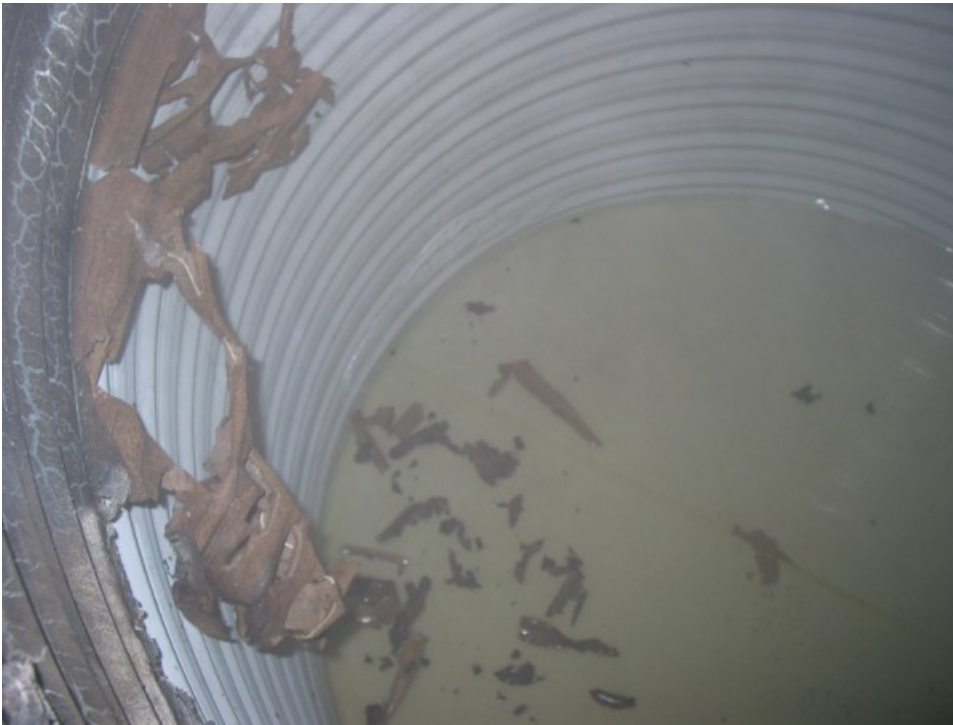
Tank 5 shows further scorches but no leaks are observed. The exterior surface temperature at the top surface of these tanks reached approximately 500°C for both tanks. Investigation of the inside of the tank showed that the tanks internal polymeric coating was intact below the waterline, above the water line the coating had thermally degraded and some of this degraded material was resting on the bottom of the tank (see Figure 16). This material did not seem to inhibit the draining of the tank, however it may be seen as an advantage to include an outlet strainer to prevent outlet clogging if these exposure conditions are considered to be a significant risk.

Figure 16 Internal polymeric coating damage above water level

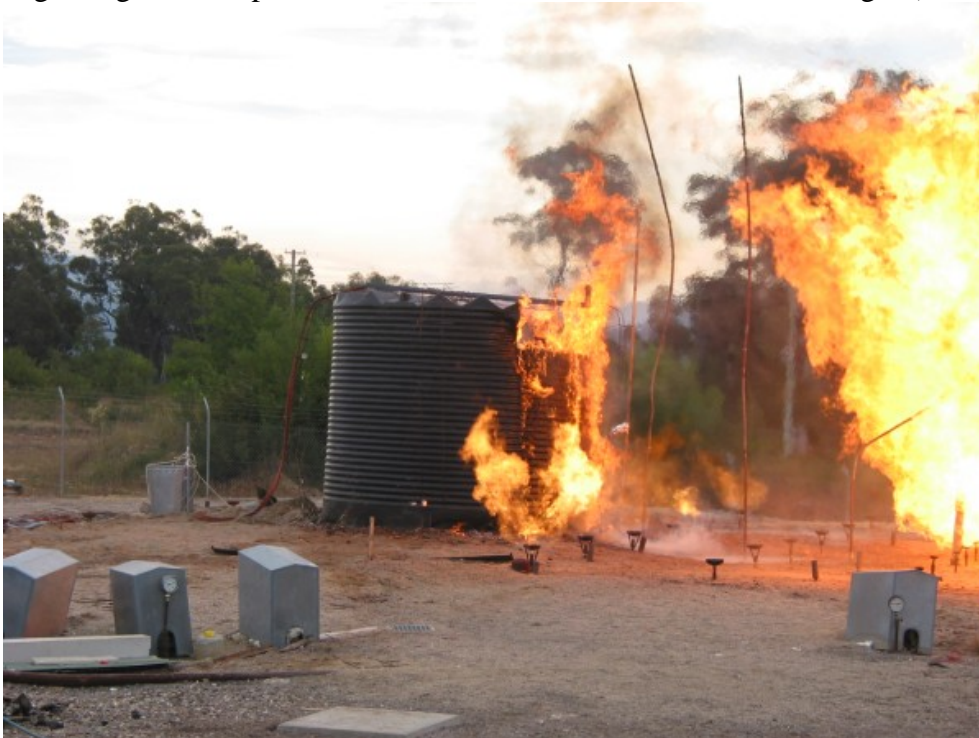
Levels of radiant heat for this exposure are shown on the Figure 32. Six minutes after the beginning of the exposure the front surface of the tank was well alight (see Figure 33).

Figure 33 Experiment 20 - Polyethylene tank

After the burners were shut off the flames reduced to small flames around the top edges of the tank. There was more melting of the top of the tank above the water level (see Figure 34) Water was flowing from around the melted rim of the tank extinguishing much of the surface combustion. The base of the tank had significant bulging and appeared to be close to structural failure.

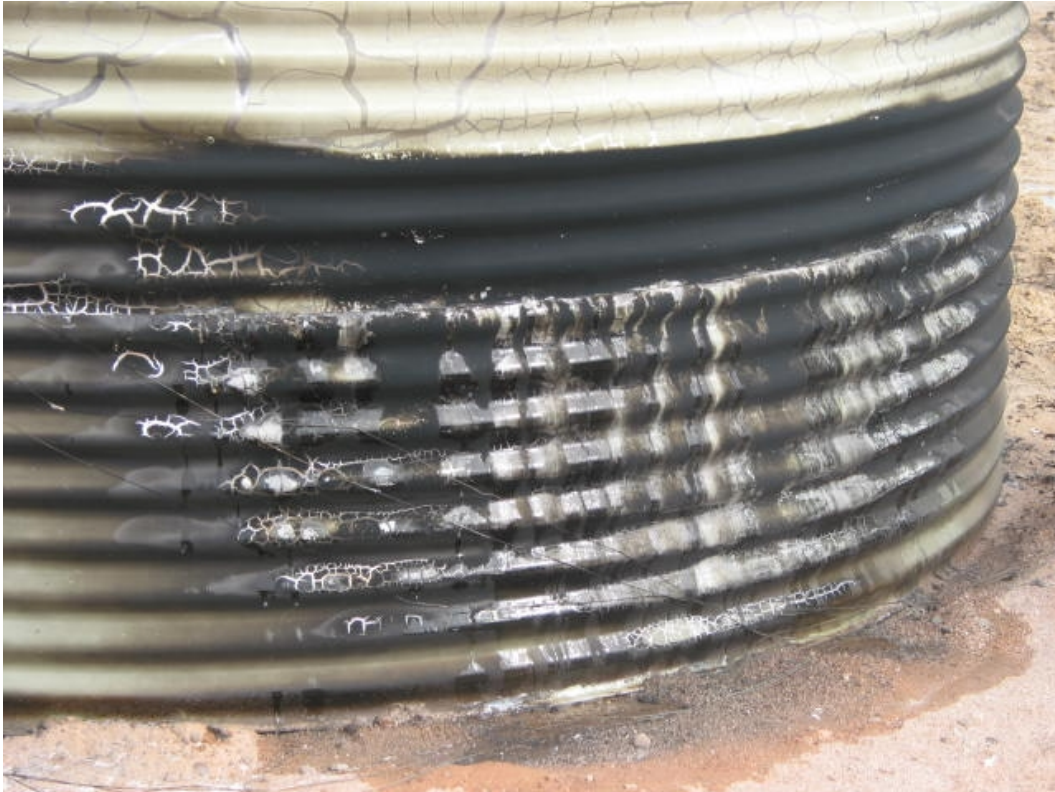
Figure C5 Tank one severe damaging resulting from structural exposure

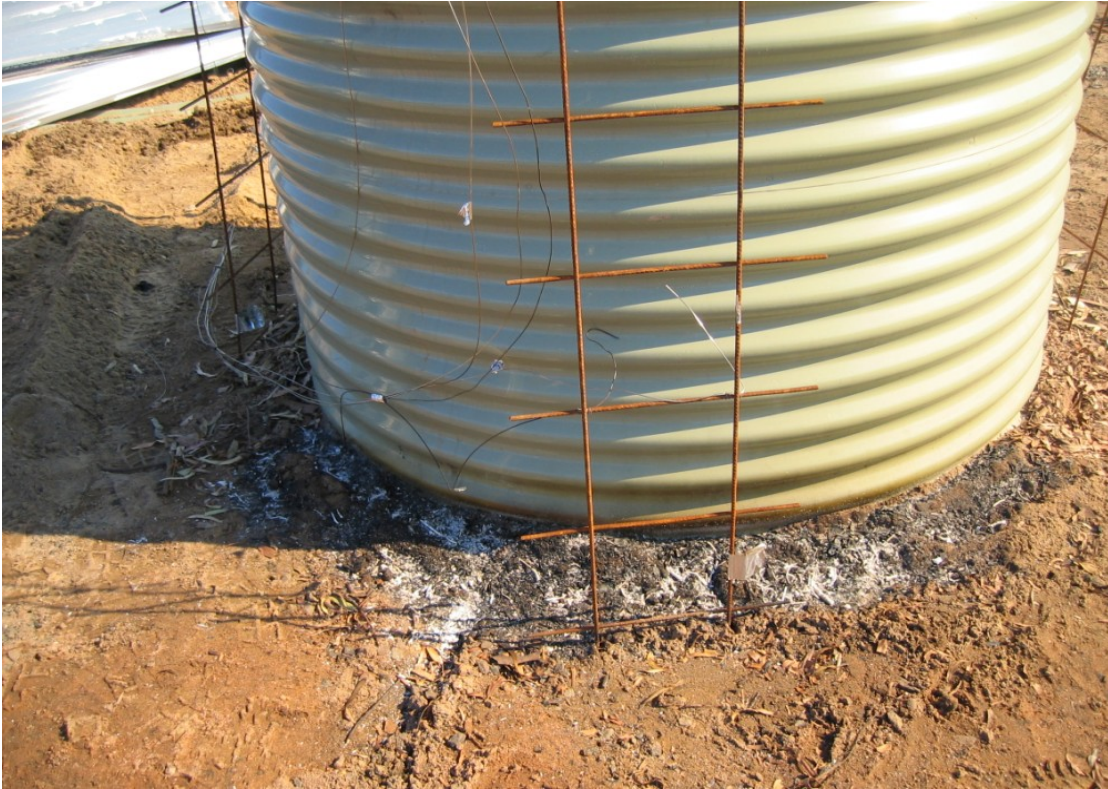
Figure C12 Tank three burnt leaf litter, no damaged to tank.

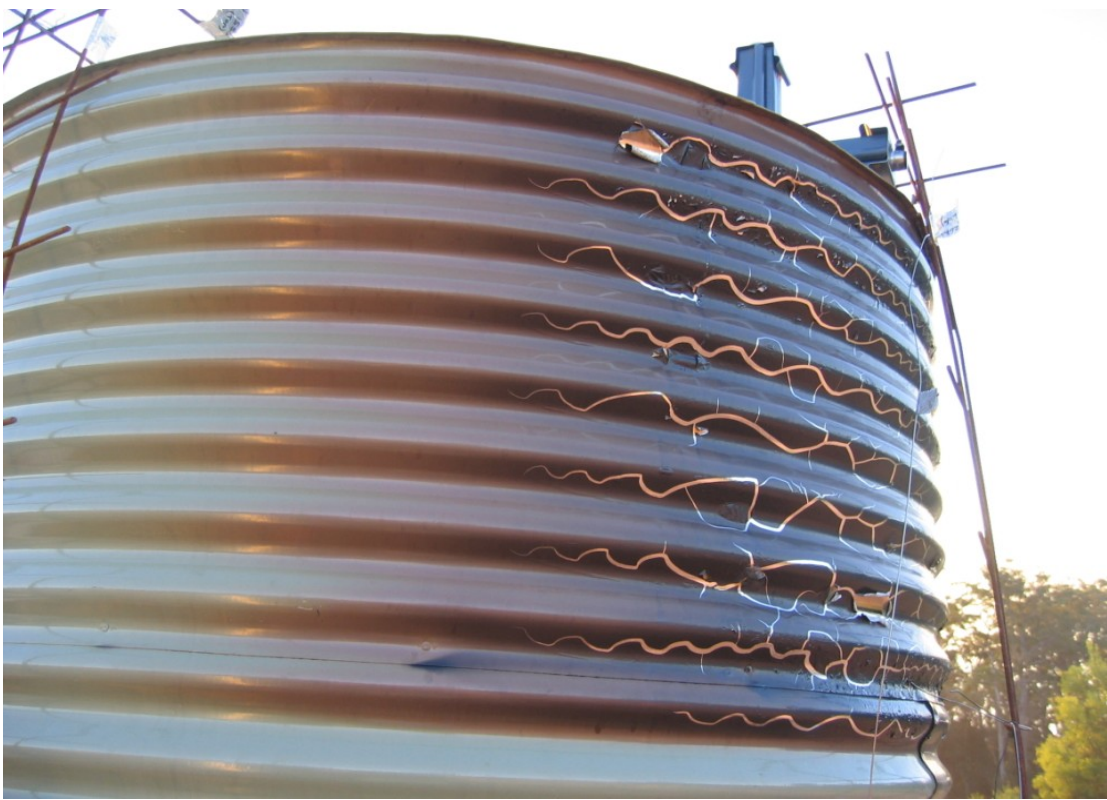
Figure C19 Tank five surface scorching above water line.

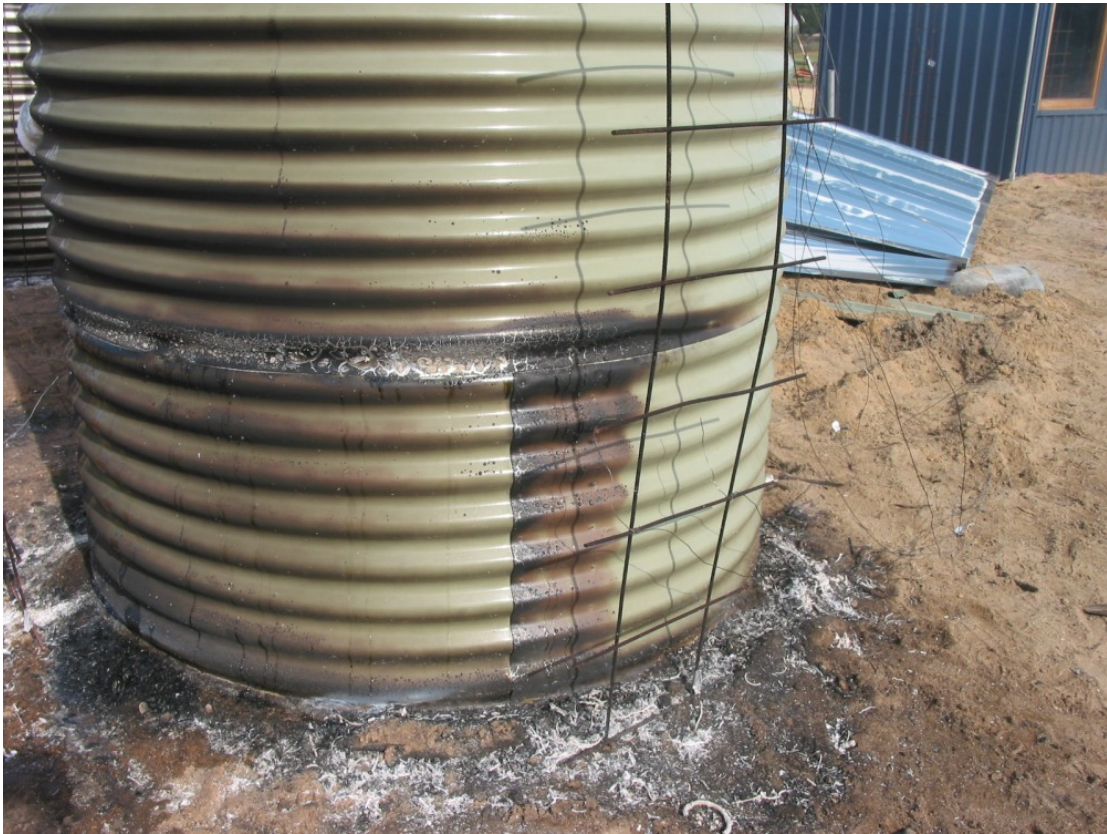
Figure C22 Tank three water leaking from damage seams.

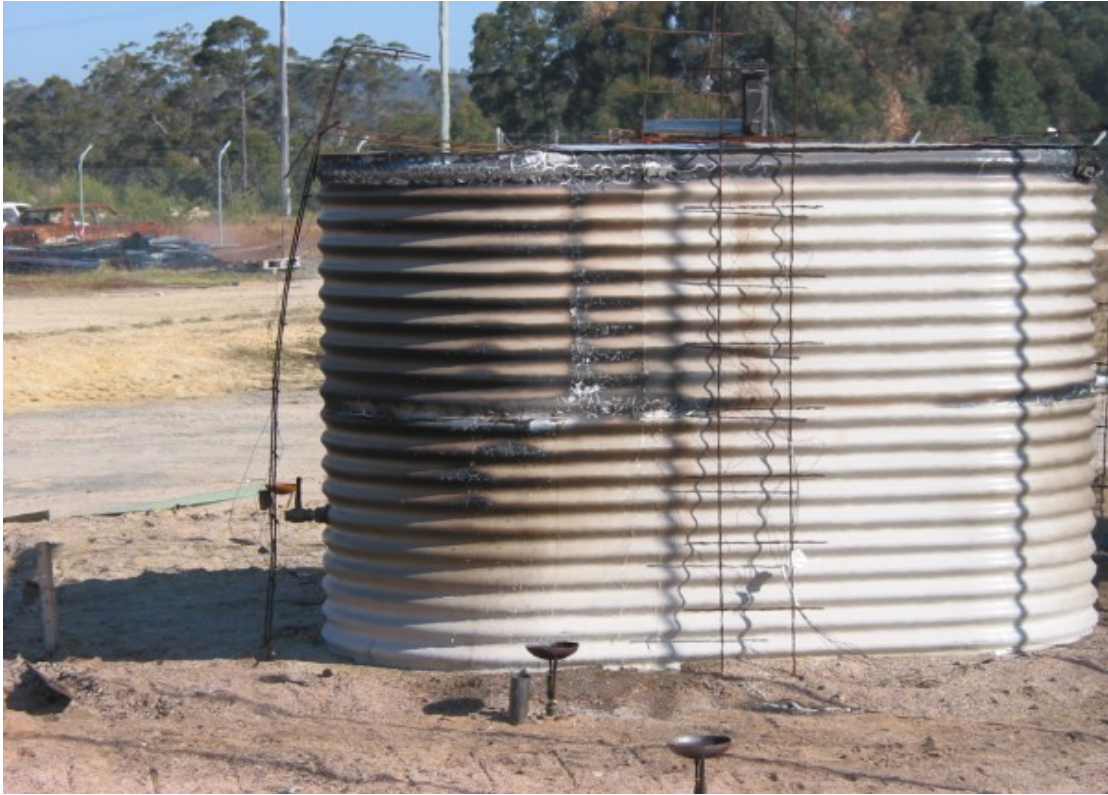
Figure C29 Tank two external damage due to flame exposure.

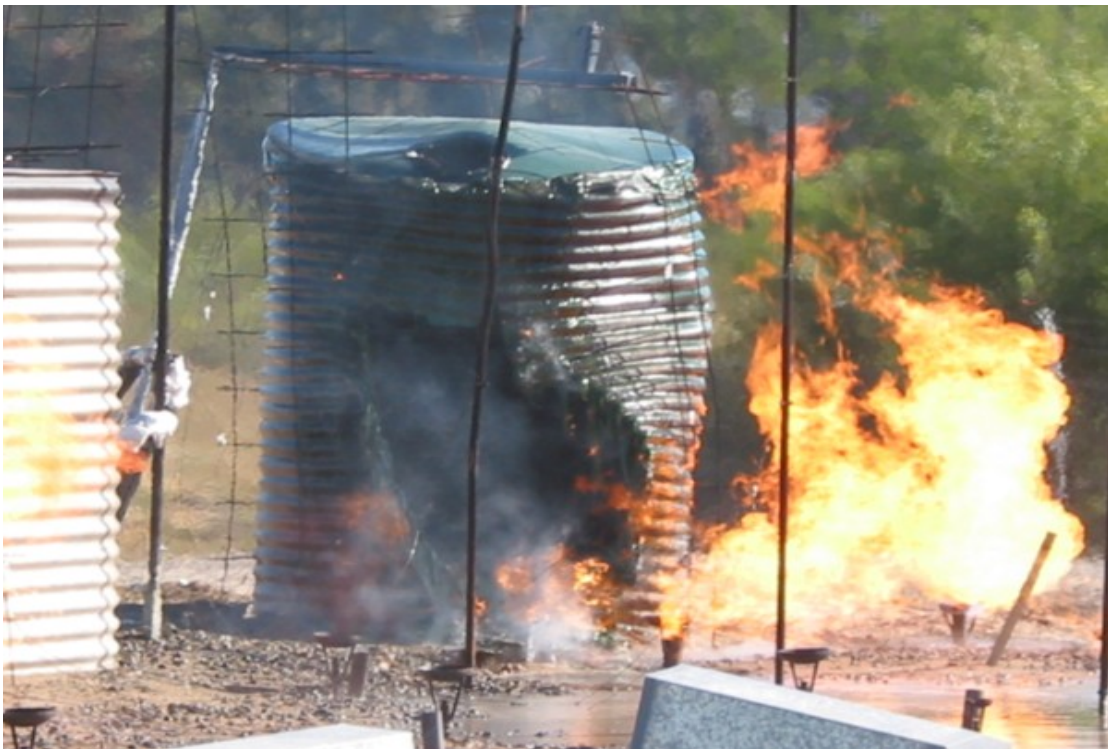
Figure C32 Tank four complete wall failure due to structural exposure.

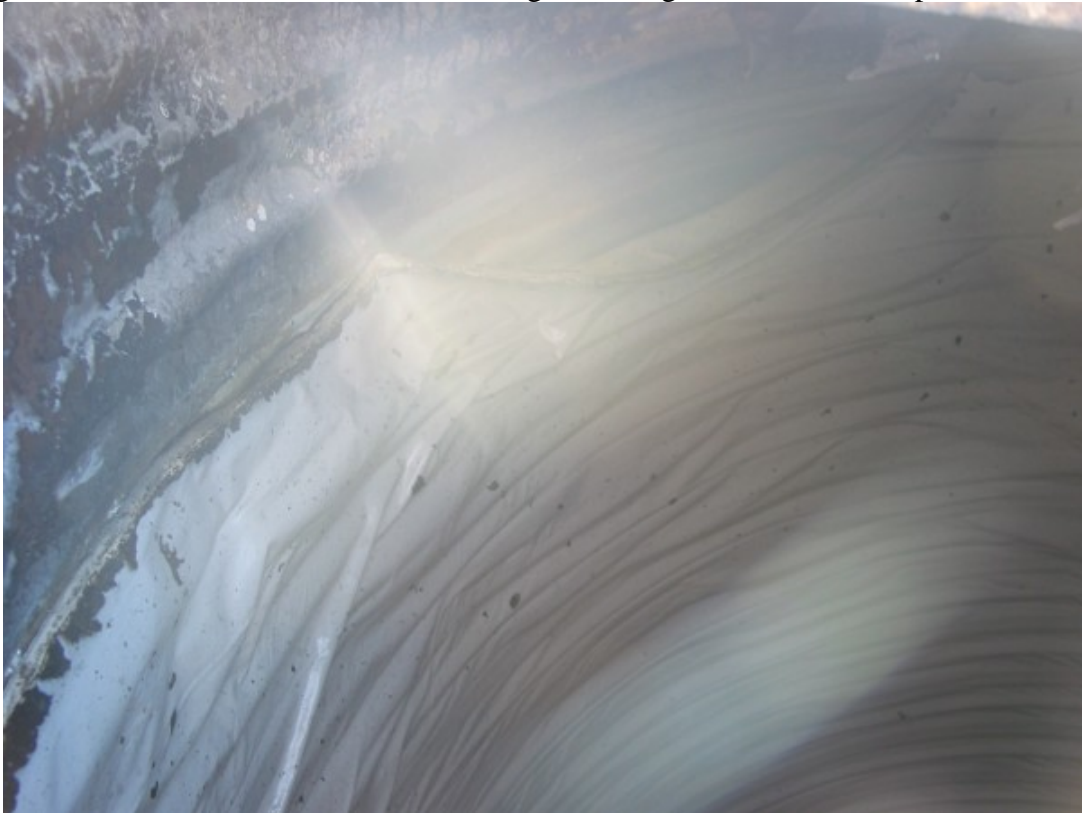
Figure C39 Tank 7 severe internal damage resulting from structural exposure.

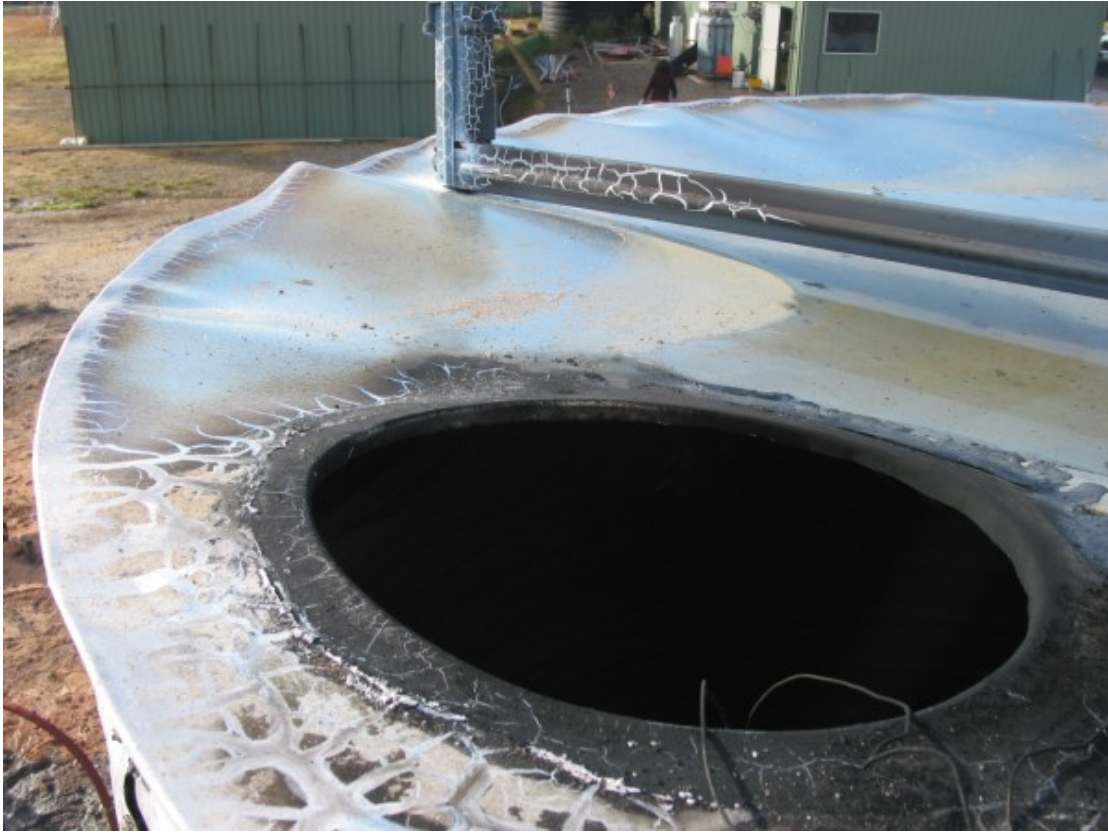
Figure C40 Tank 7 damage resulting from structural exposure.

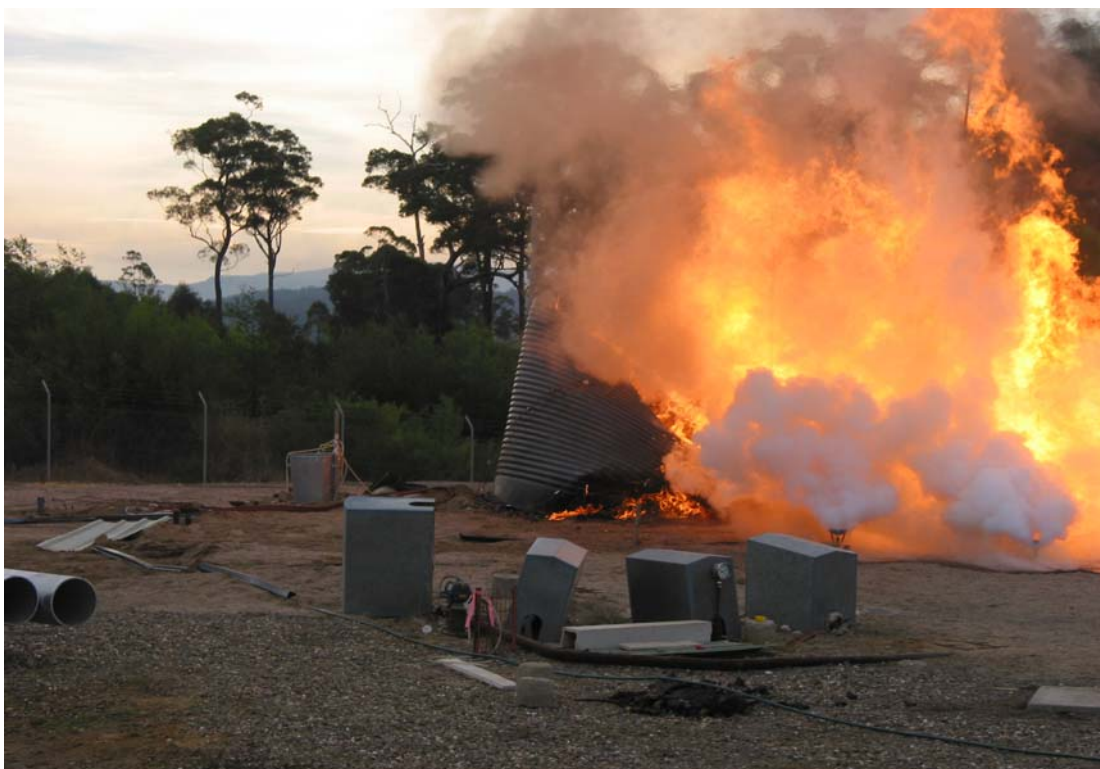
Figure C53 Tank 8 ignition and initial stages of failure due to structural fire exposure.

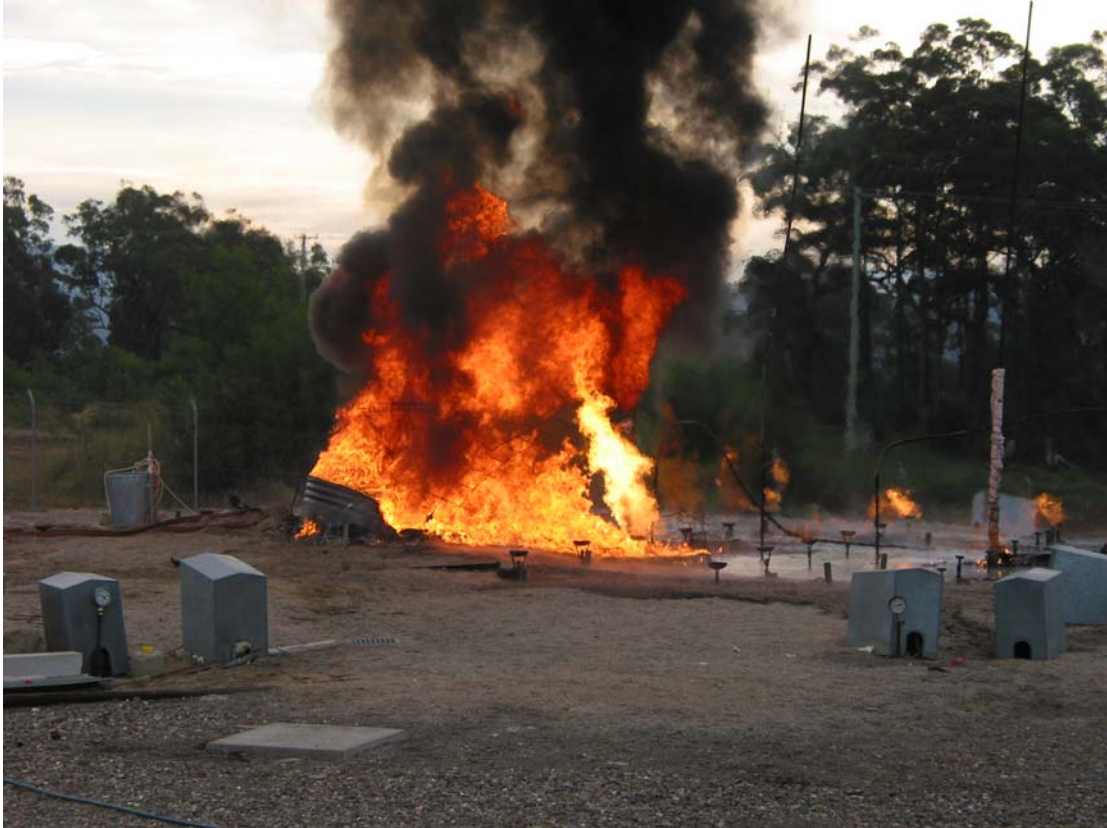
Figure C54 Tank 8 failure due to structural fire exposure.

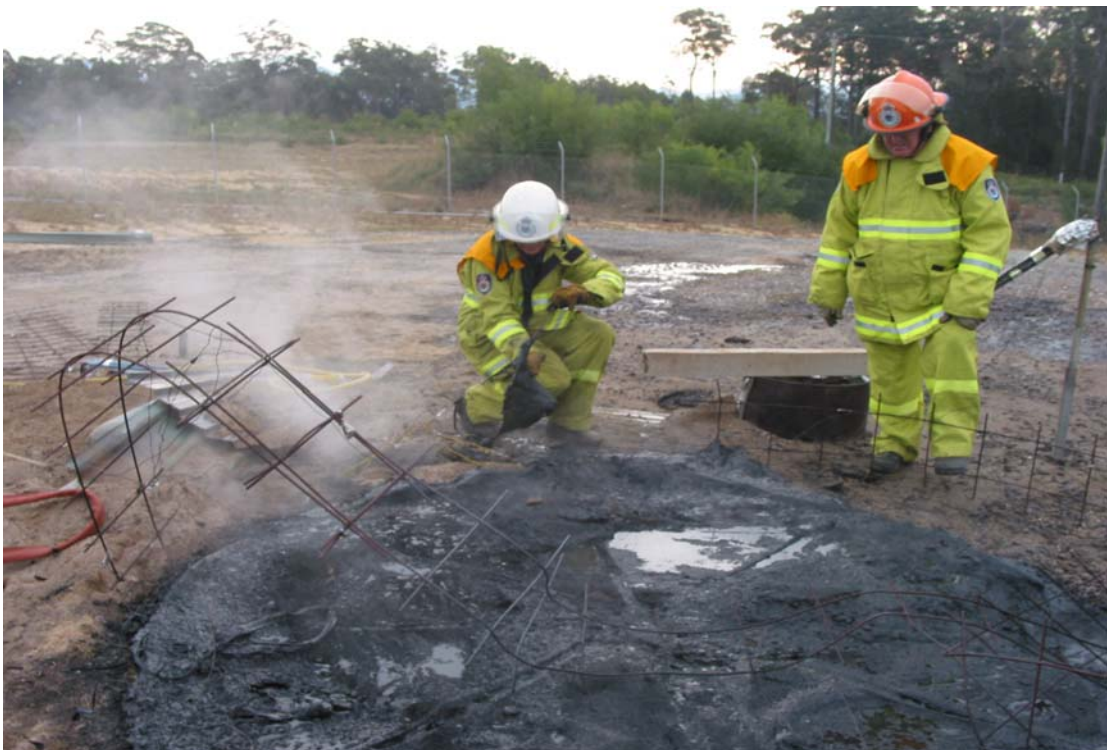
Figure C55 The remains of what was tank eight.

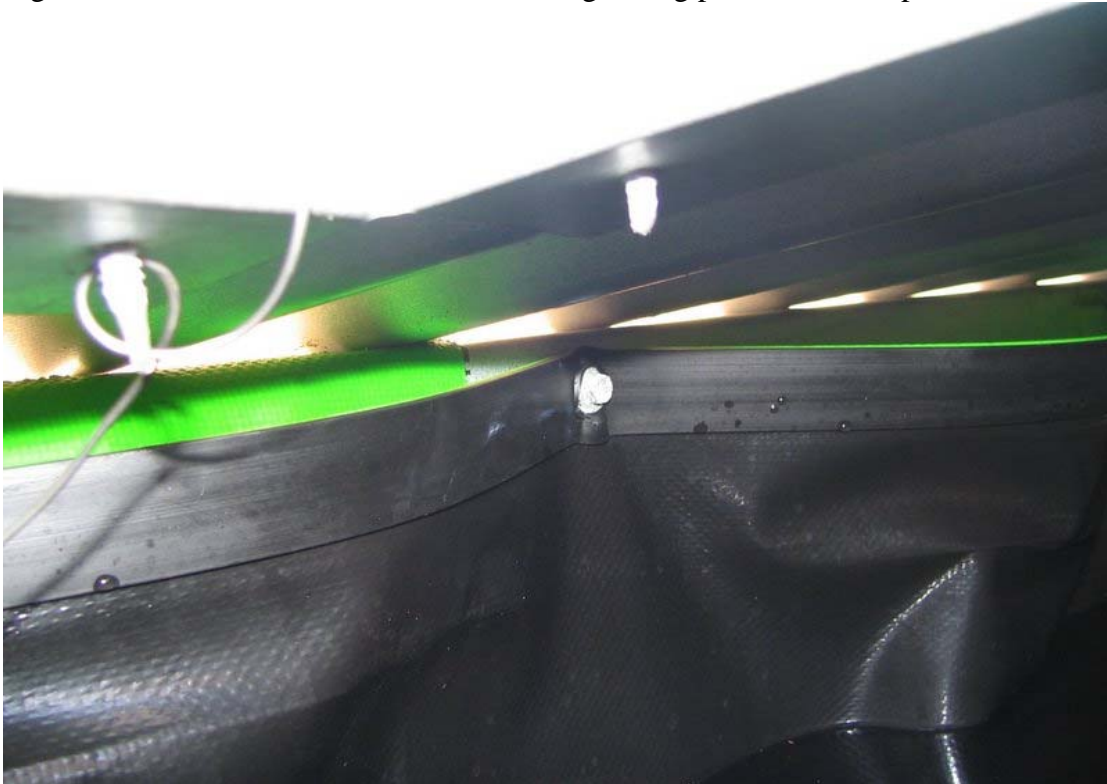
Figure C59 Bladder tank liner slightly damaged due to pre-radiation exposure.

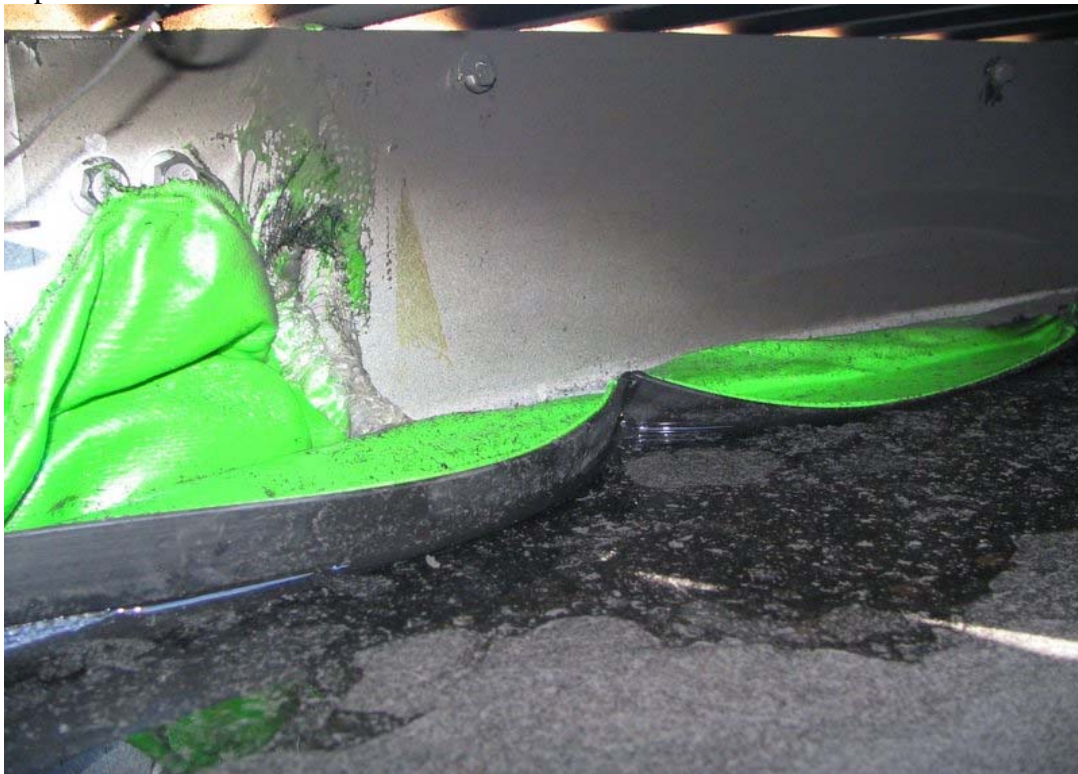
Figure C63 Damage to bladder tank liner resulting from pre-radiation and flame exposure.

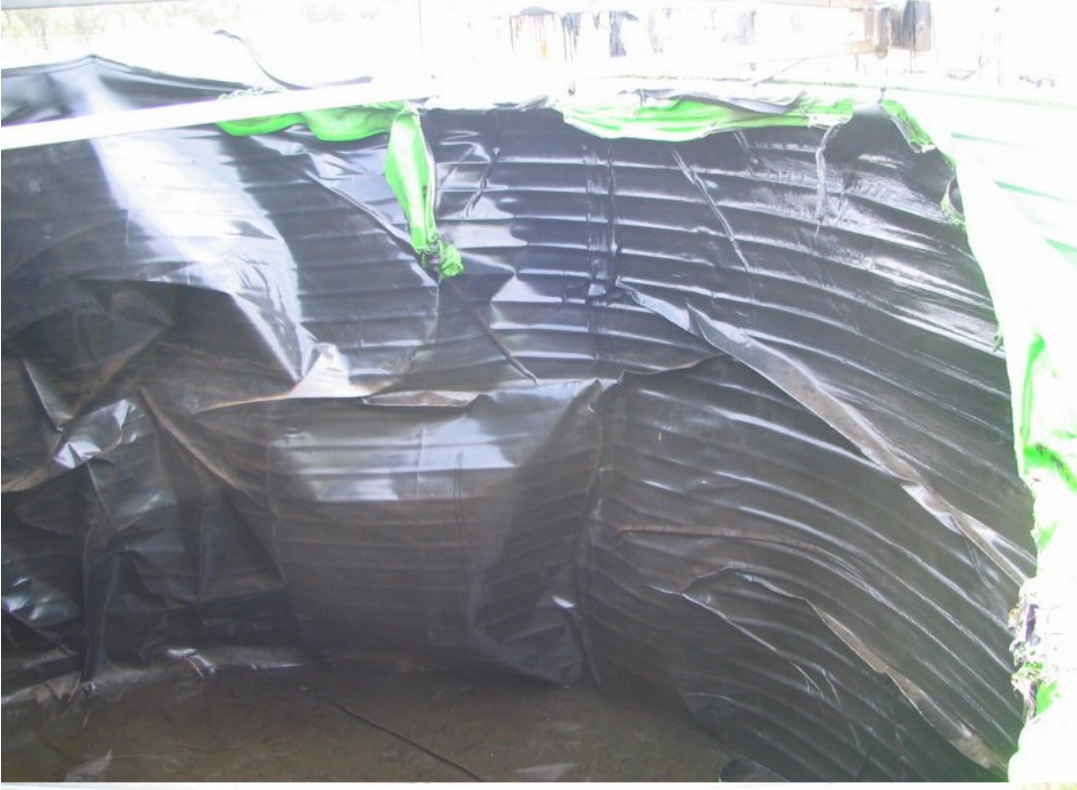
Figure C67 Damage to tank 9 liner resulting from structural fire exposure.

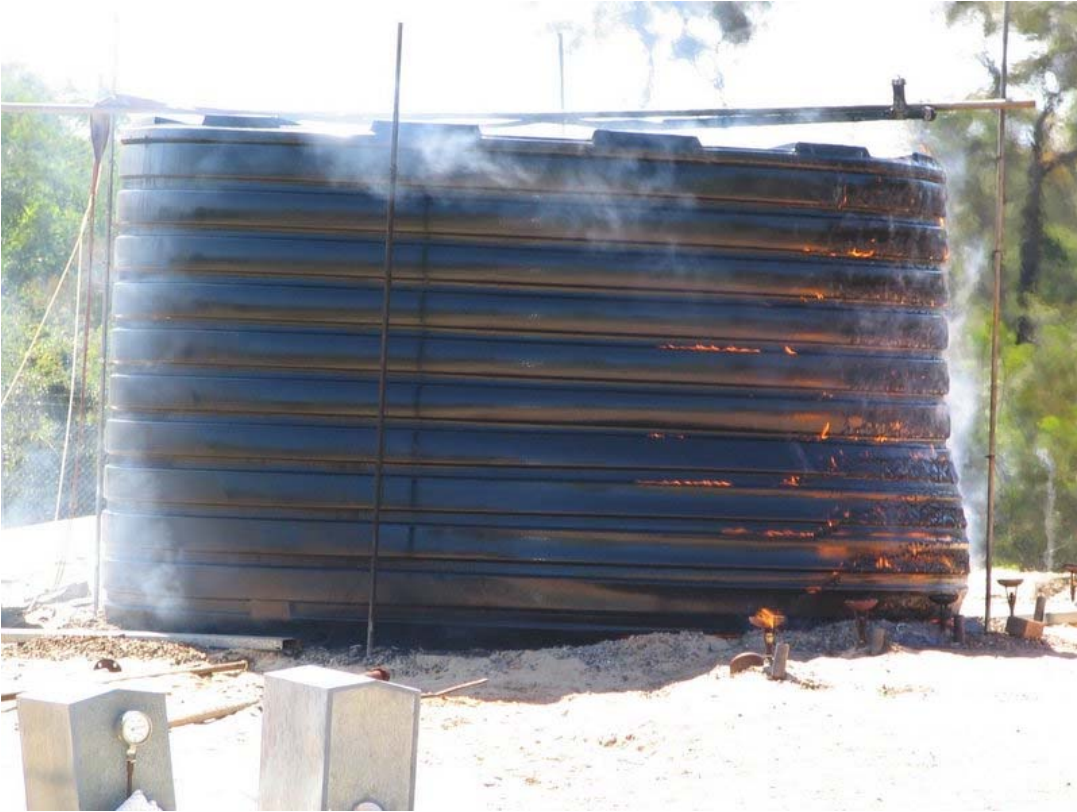
Figure C70 Tank 10 continuing to burn post the litter ignition and pre-radiation exposure.

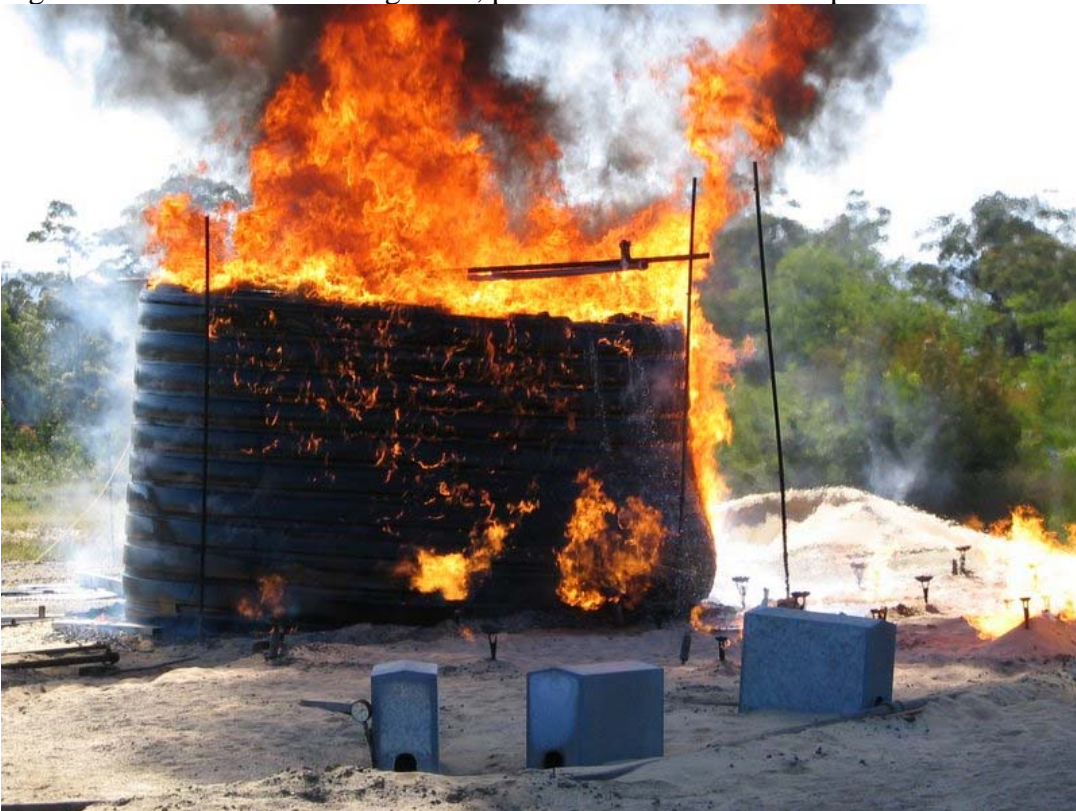
Figure C73 Tank 10 completely alight and about to fail as a result of litter ignition, pre-radiation and flame exposure.

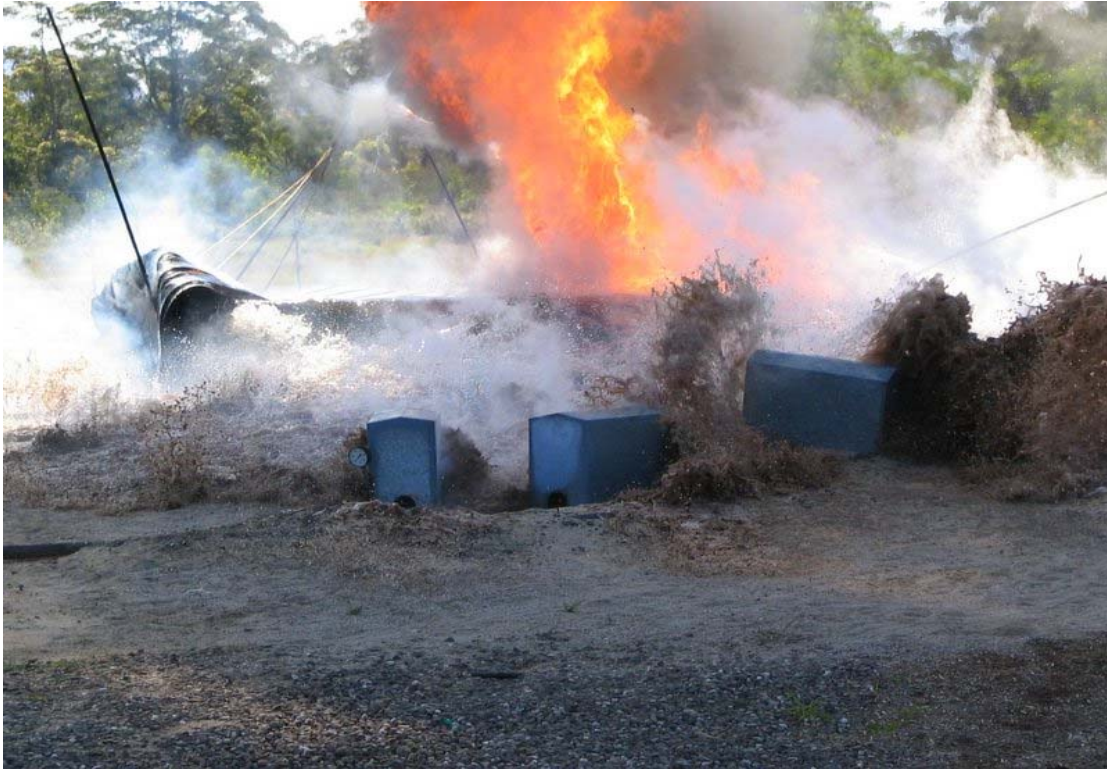
Figure C73 Tank 10 completely failing with contents flowing out due to flame exposure.

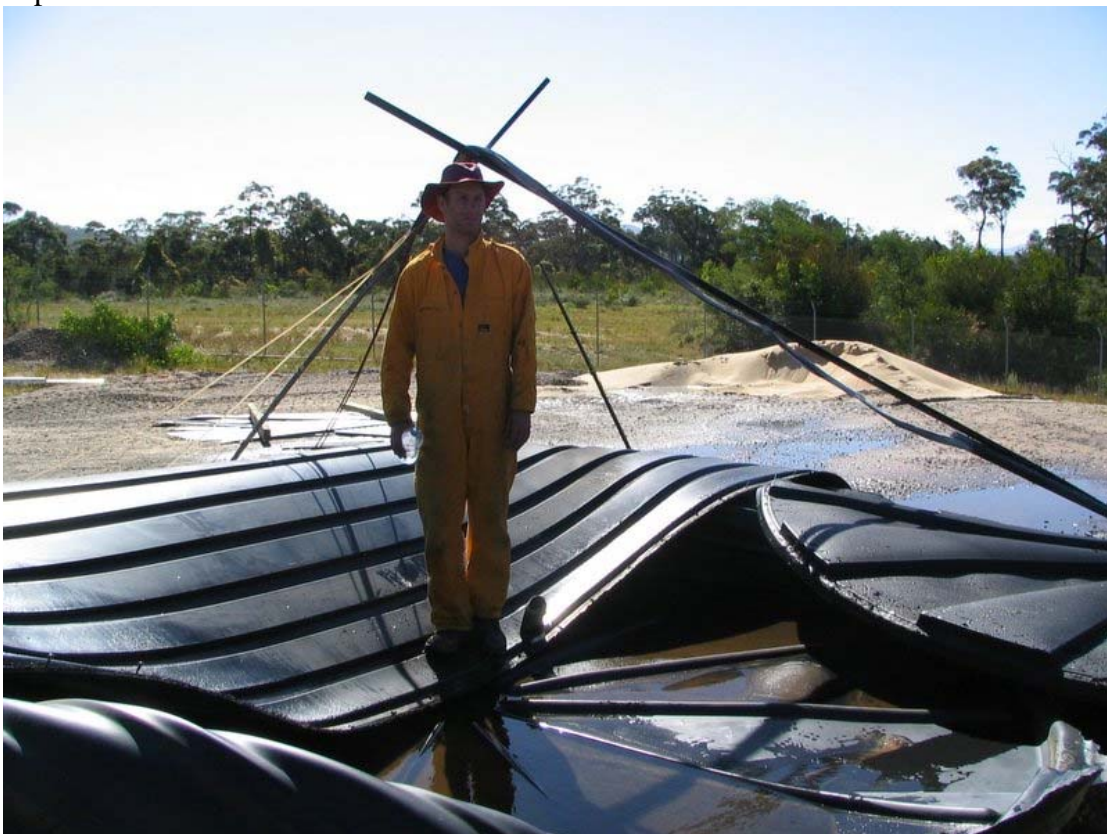
Figure C74 What remains of the completely destroyed tank 10.
