**RESEARCH INTO THE PERFORMANCE OF
WATER TANKS IN BUSHFIRE
-Bushfire CRC Project D1**

**R. Blanchi, J.E. Leonard, N. White, A. Sargeant, A. Bicknell, S Andersson
CSIRO – Sustainable Ecosystems (CSE)
Urban Systems Program**

USP2007/014

December 2007

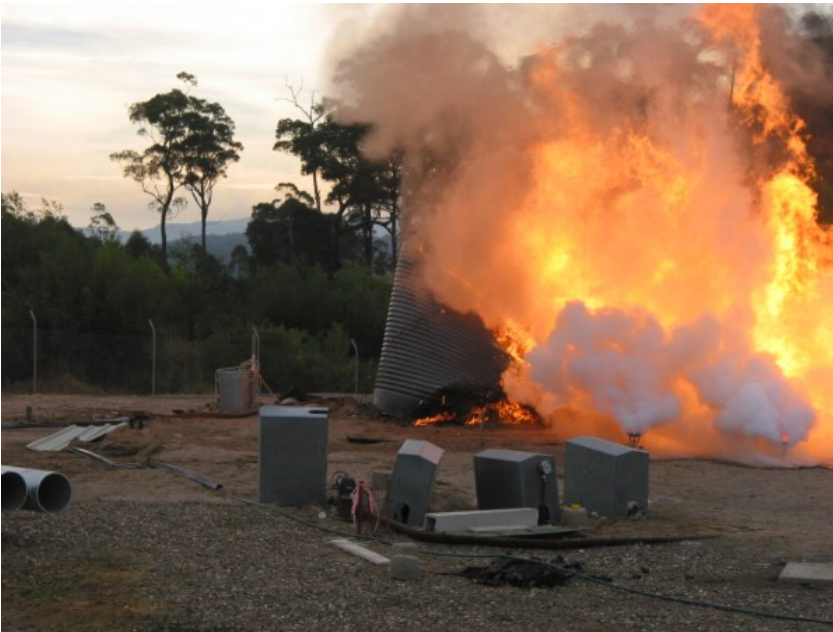
Two minutes after the beginning of the structural exposure the tank unzipped and emptied completely (see Figure 35).

Figure 35 Experiment 21 polyethylene tank at two minutes into tests

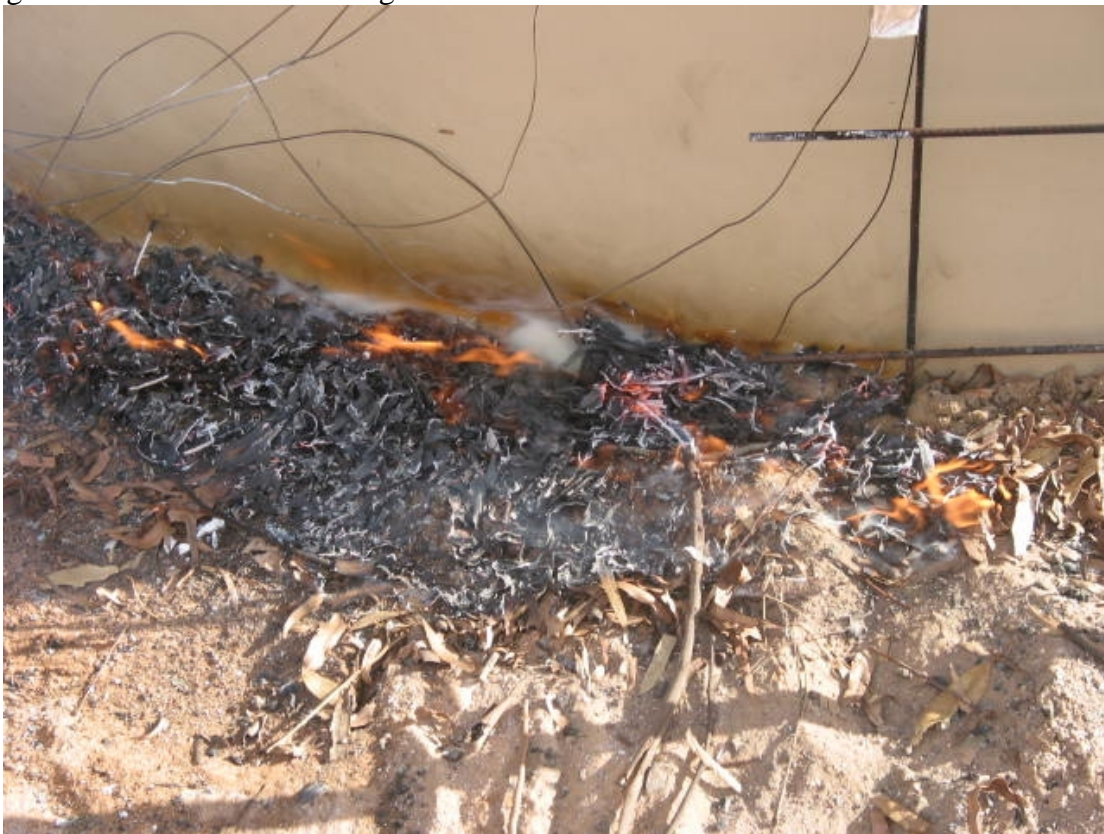
Figure C8 Tank six smouldering litter contacting exterior of tank.

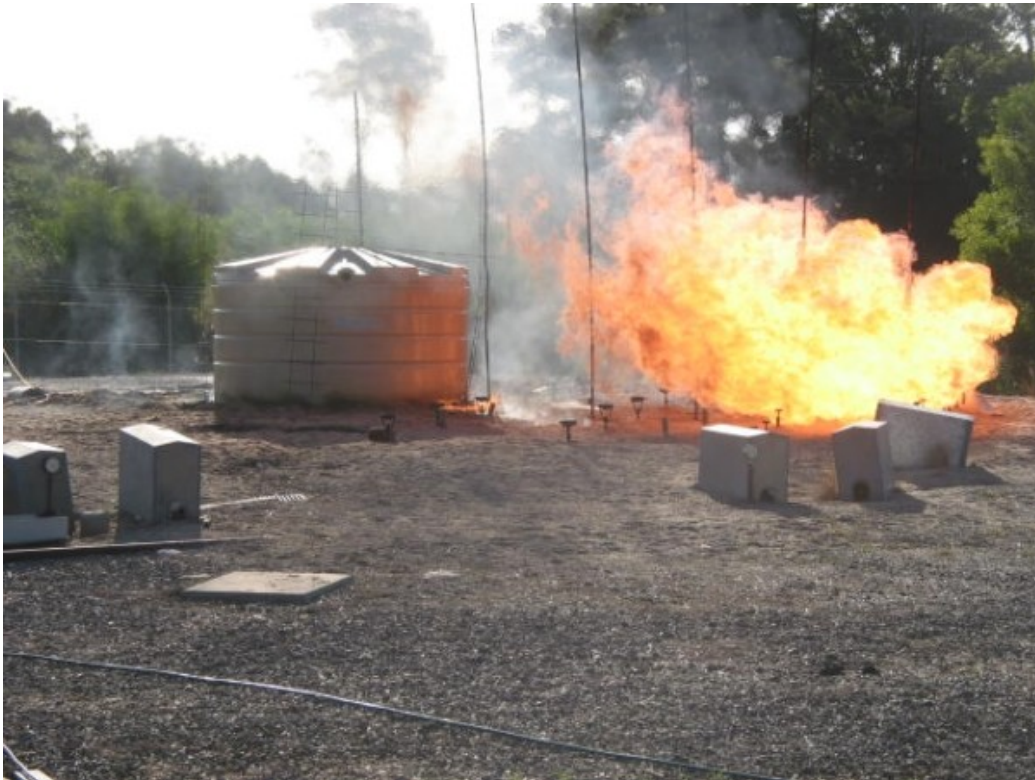
Figure C9 Tank six pre radiation exposure. Approx 25Kw/m^2

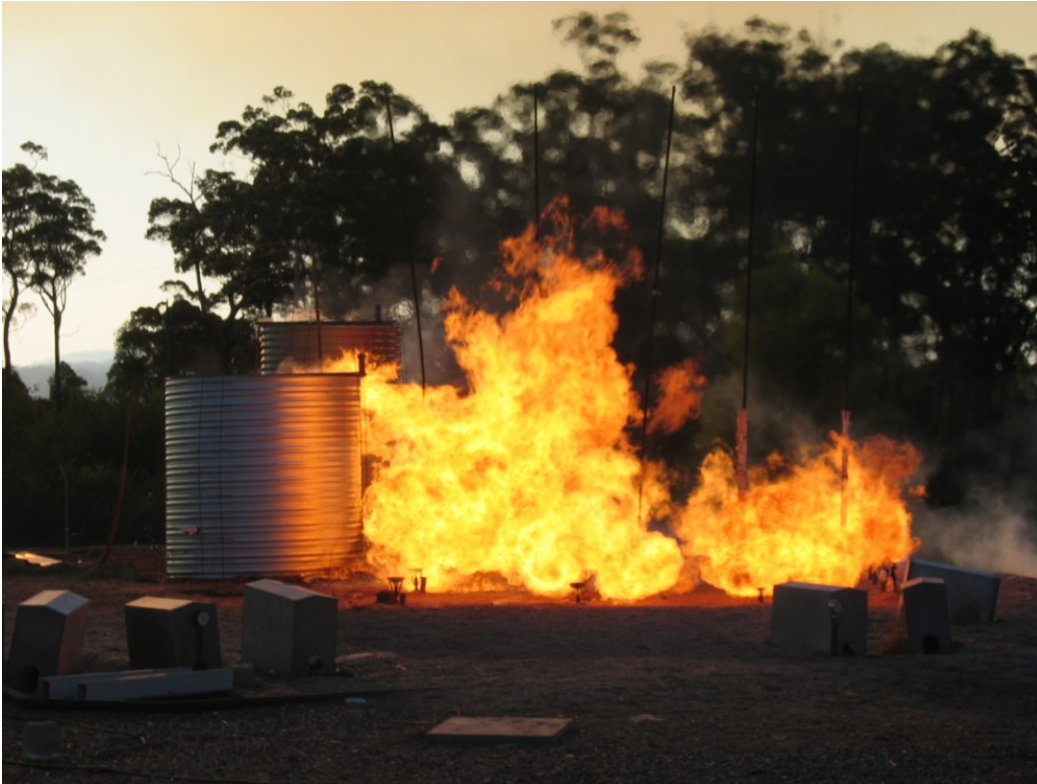
Figure C16 Tank three and five pre radiation flame contact.

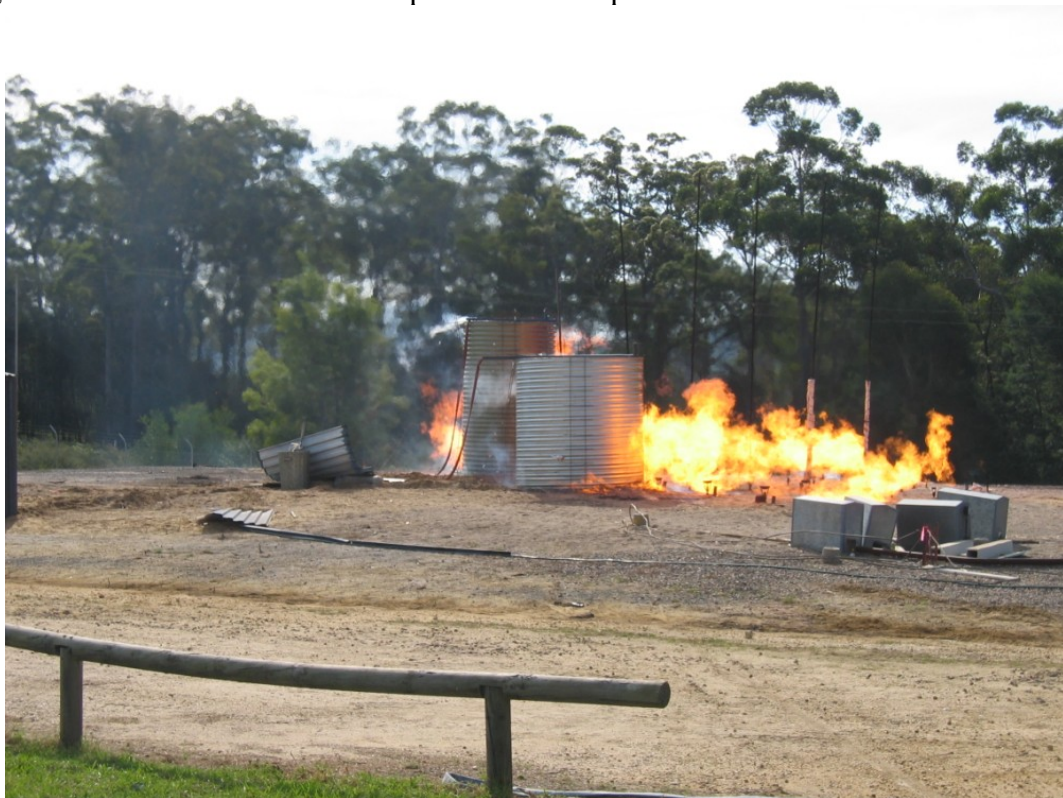
Figure C21 Tank three and five flame exposure.

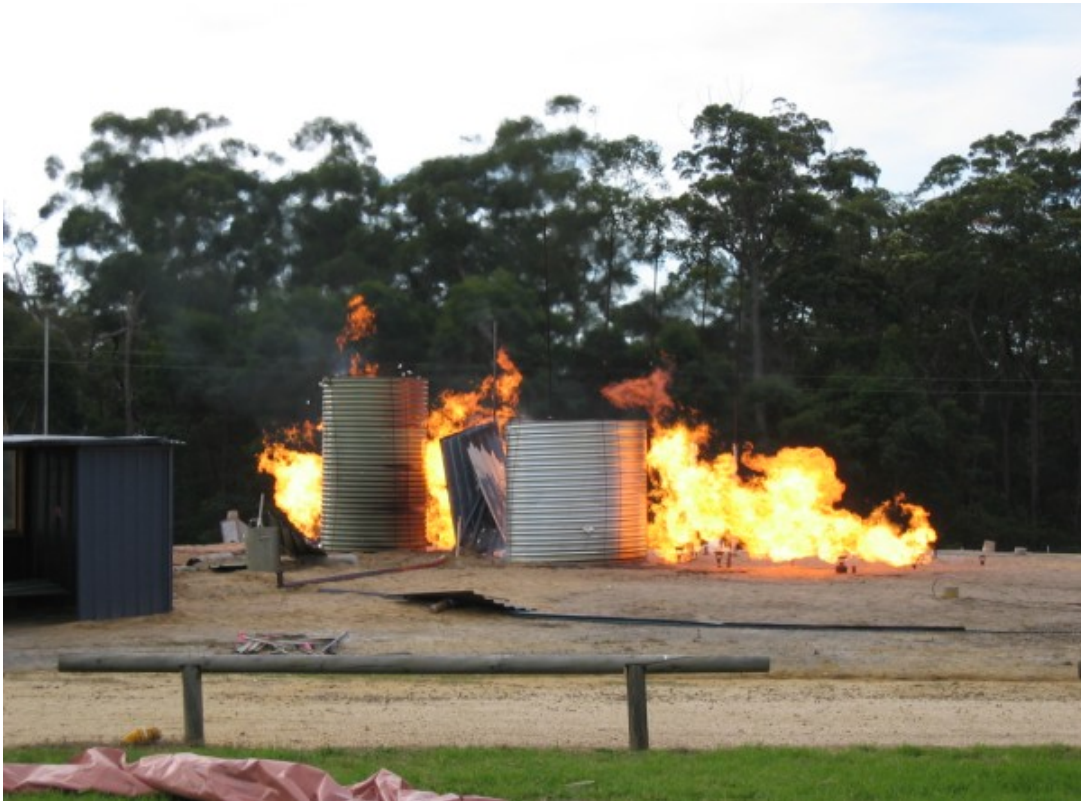
Figure C23 Tank three and five flame exposure.

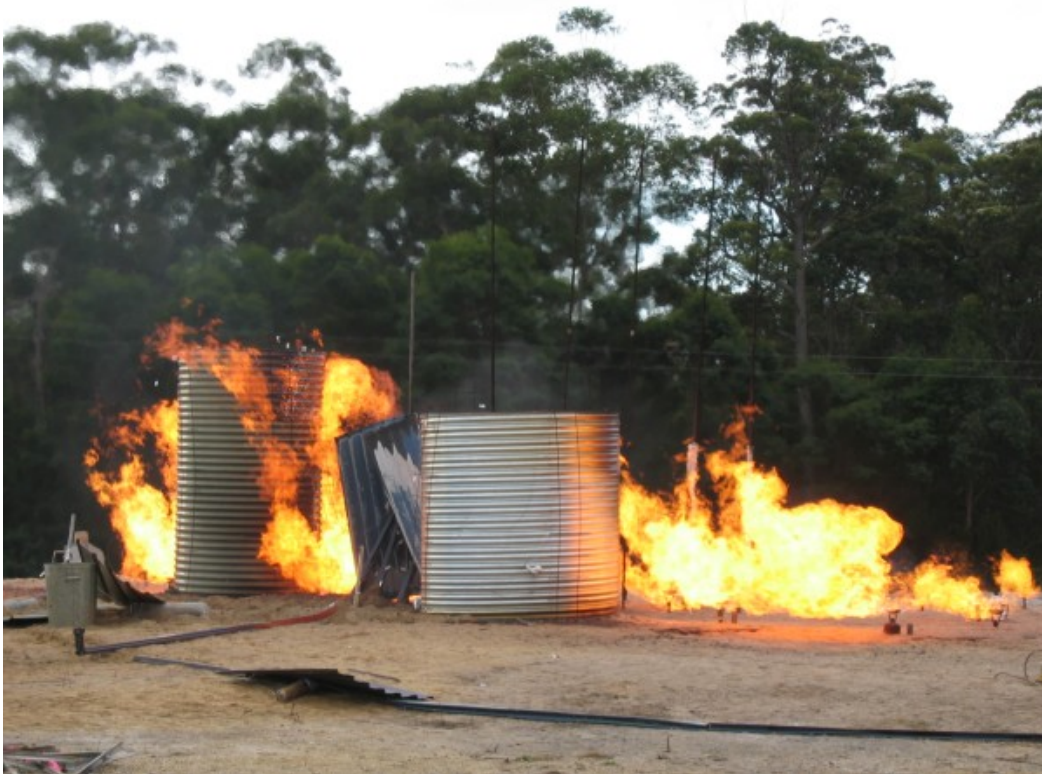
Figure C24 Tank three and five flame exposure.

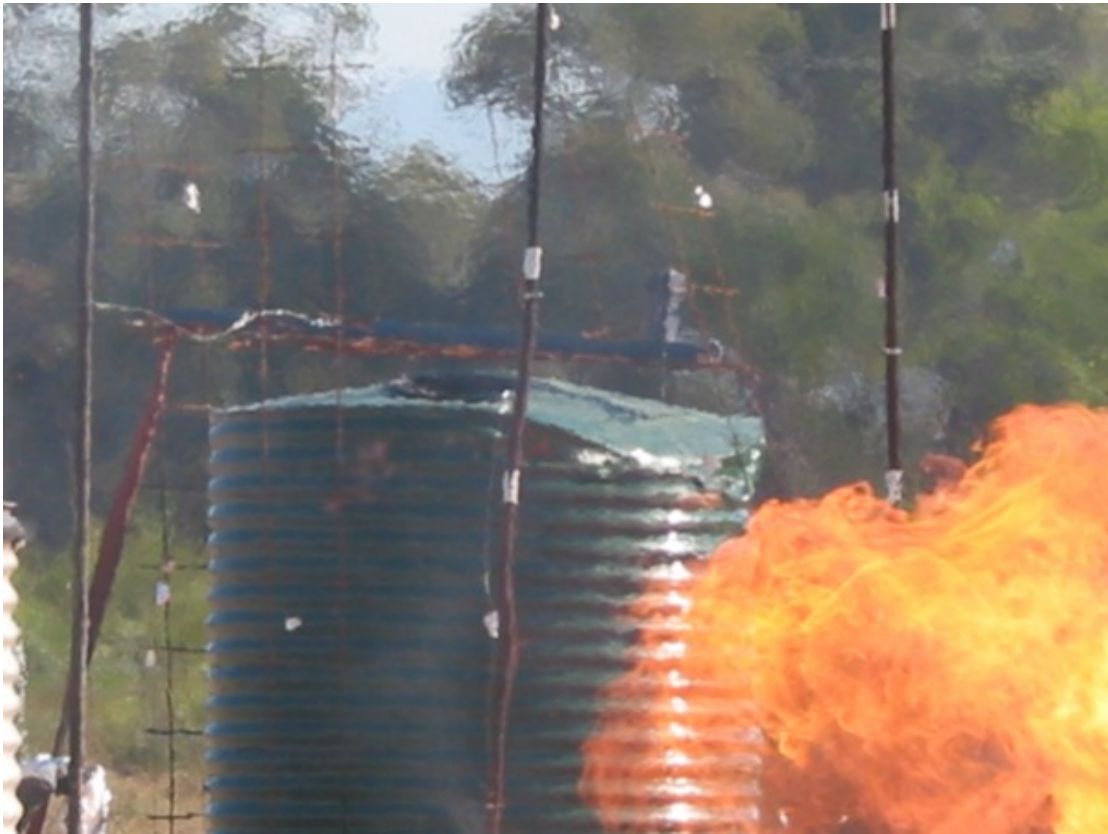
Figure C27 Tank four pre-radiation exposure.

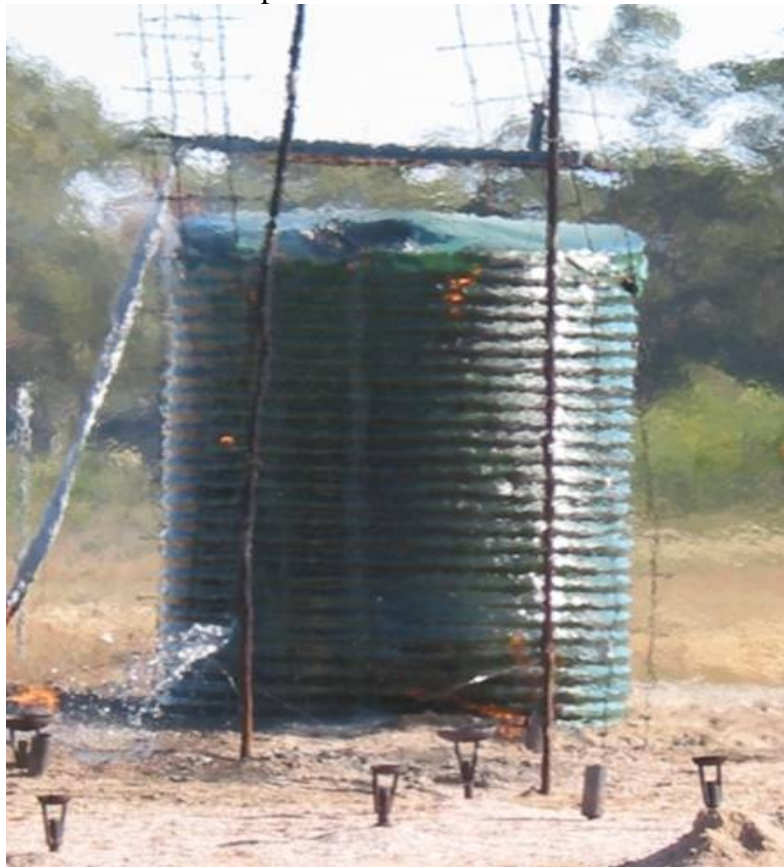
Figure C28 Tank four severely leaking due to flame exposure.

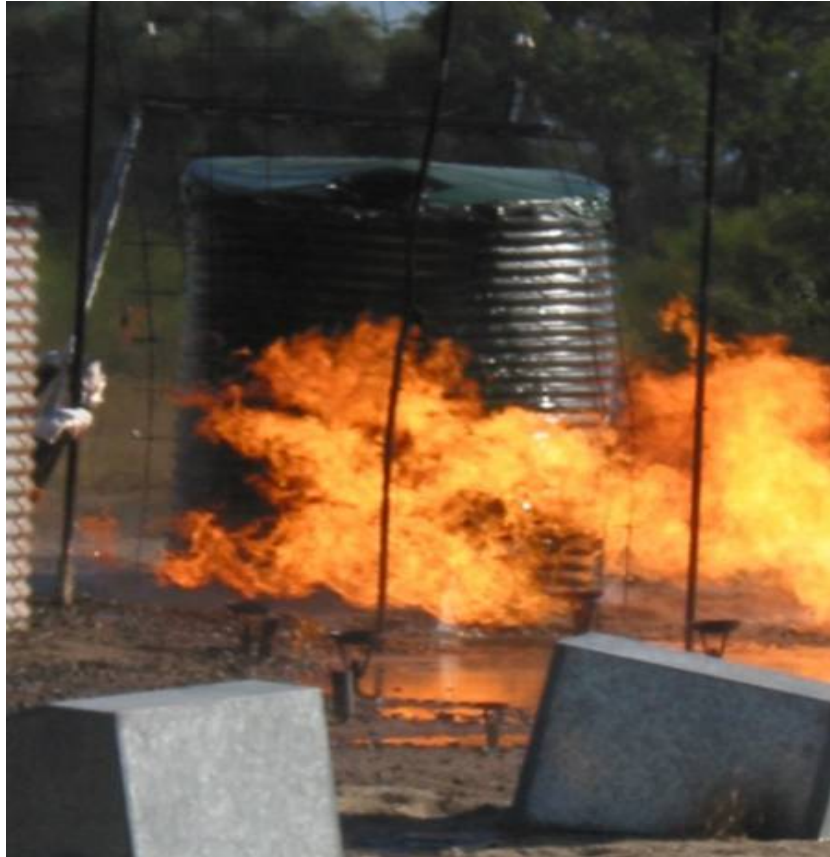
Figure C30 Tank four structural exposure.

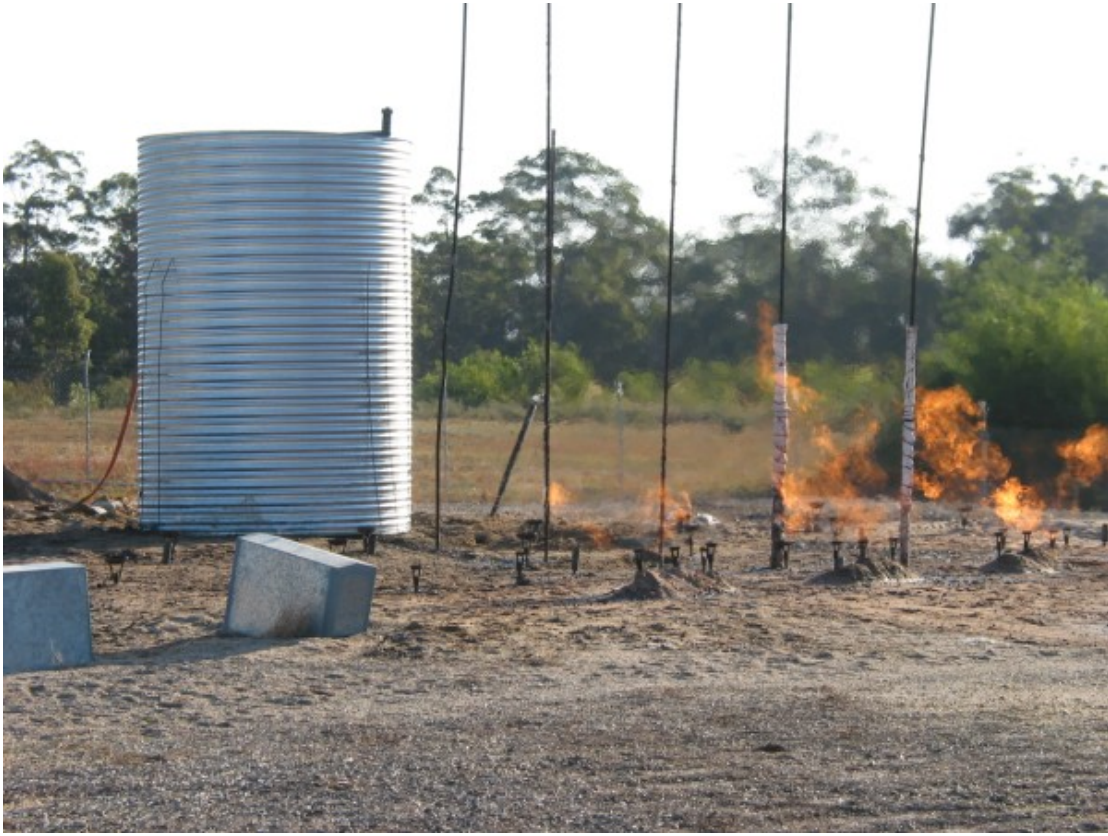
Figure C33 Tank 7 prior to pre-radiation exposure.

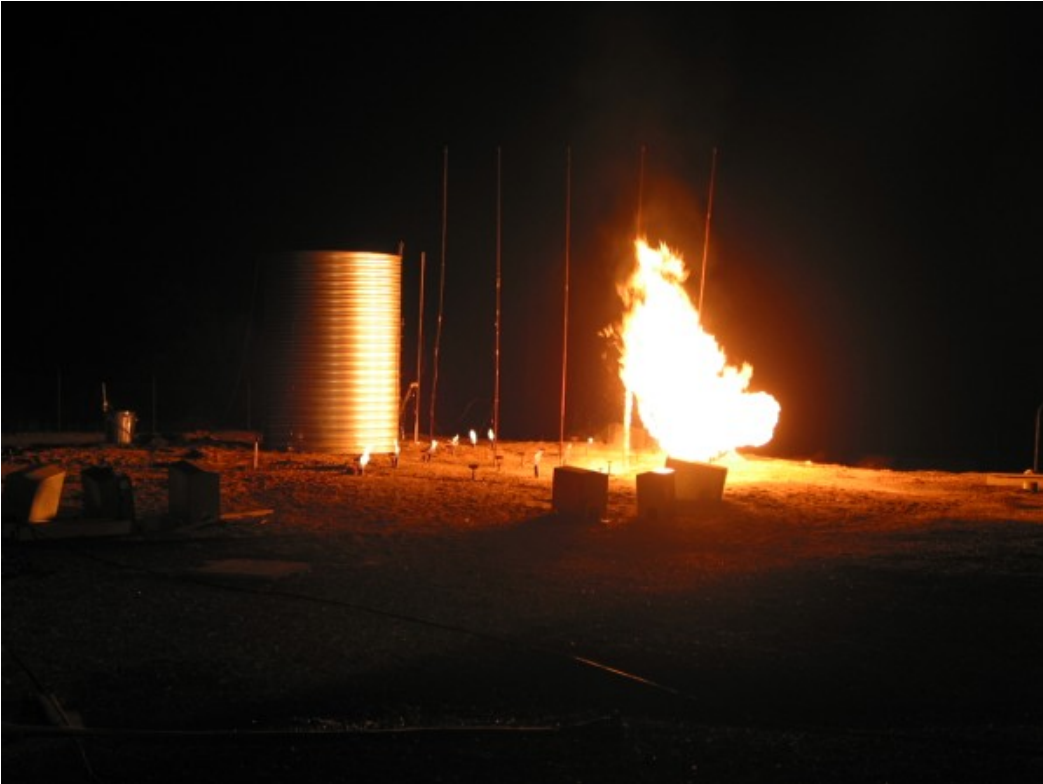
Figure C34 Tank 7 pre-radiation exposure.

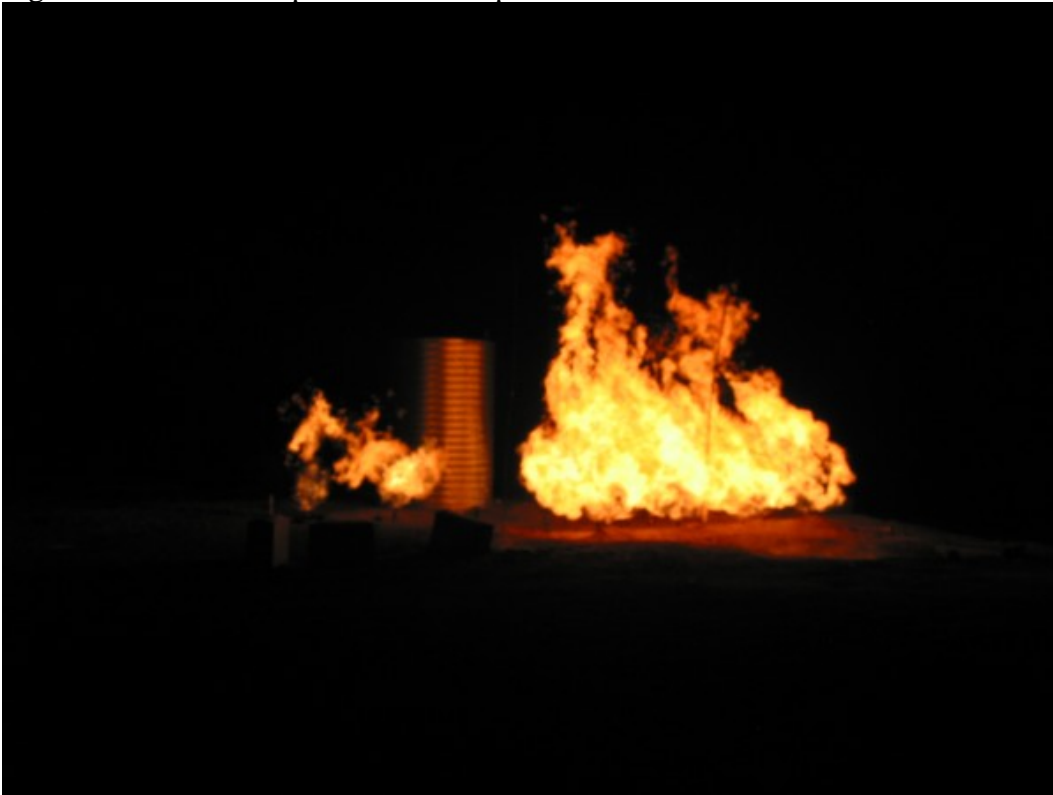
Figure C35 Tank 7 pre-radiation exposure.

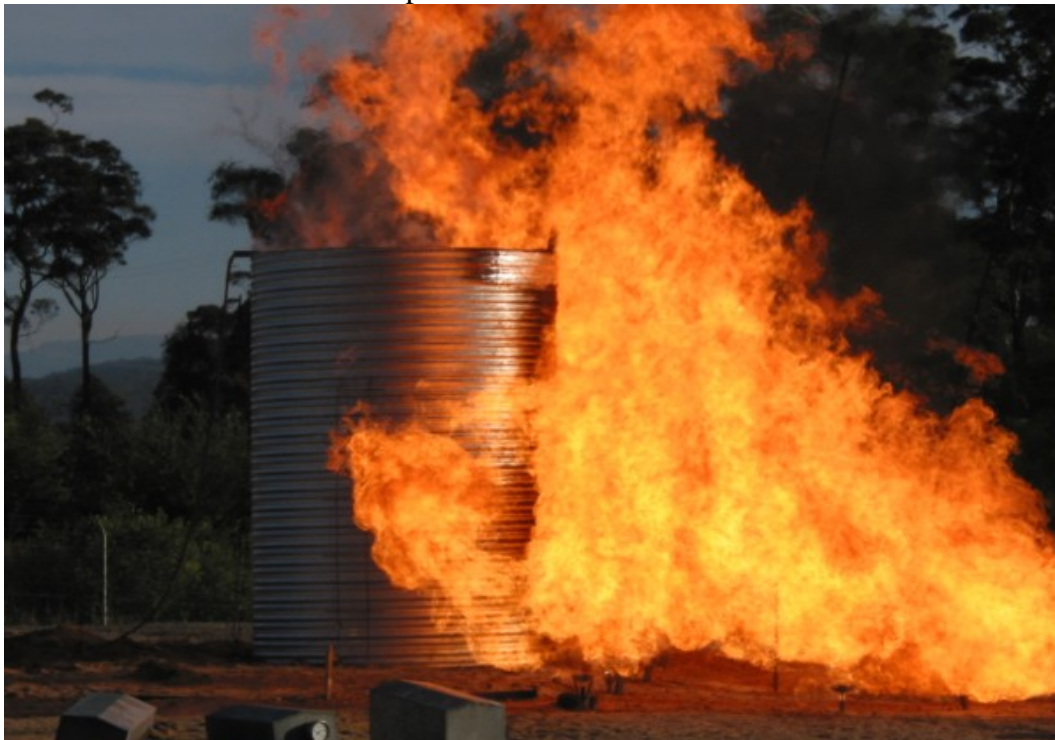
Figure C37 Tank 7 structural exposure.

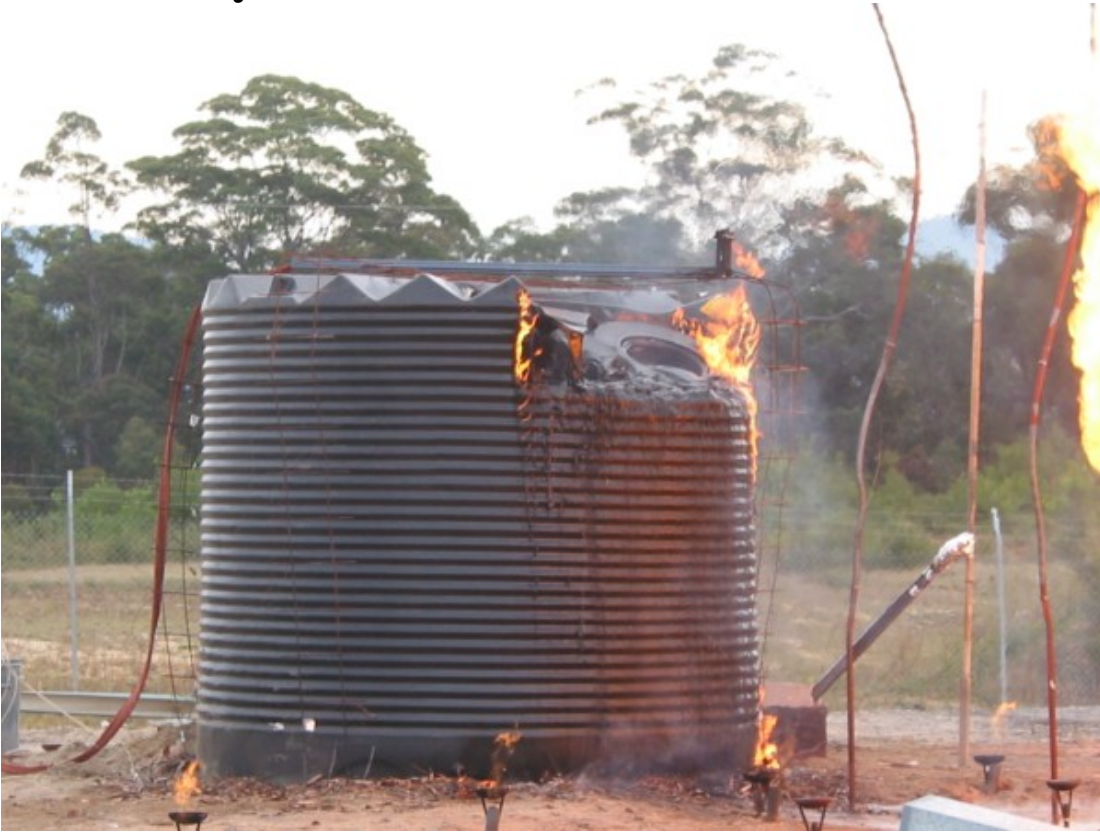
Figure C46 Tank 8 ignition as a result of litter ignition and pre-radiation and flame exposure.

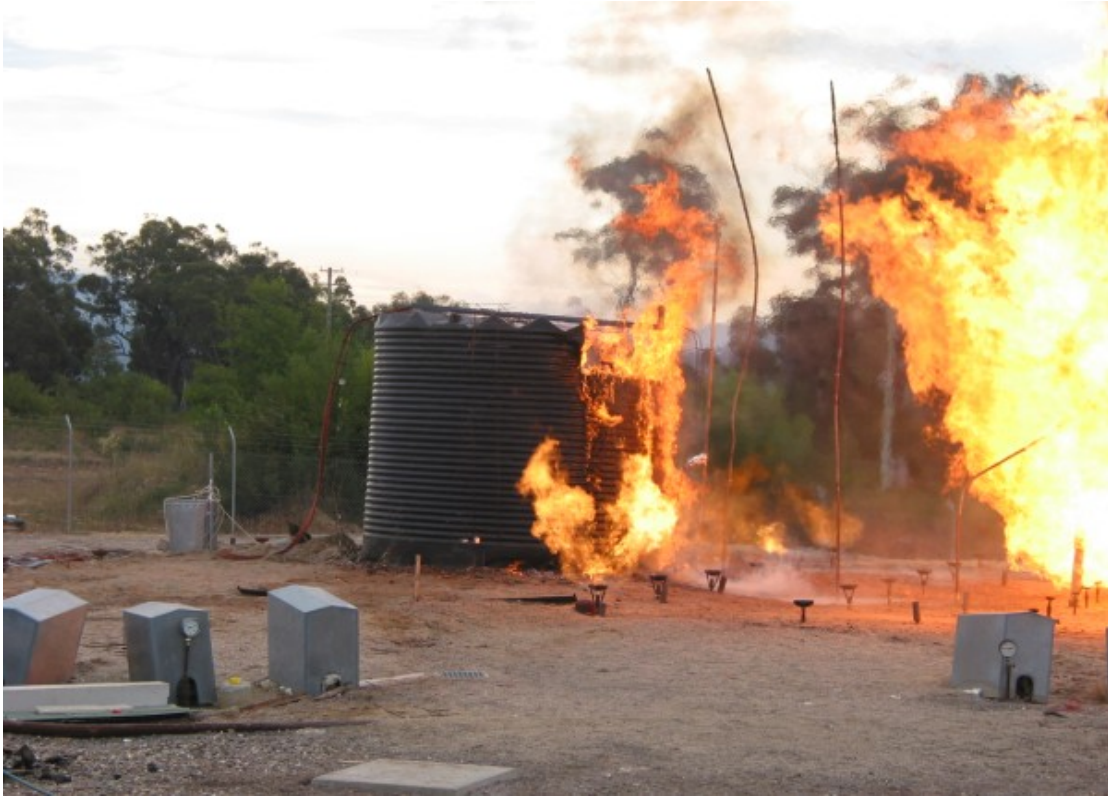
Figure C49 Tank 8 ignition as a result of litter ignition and pre-radiation and flame exposure.

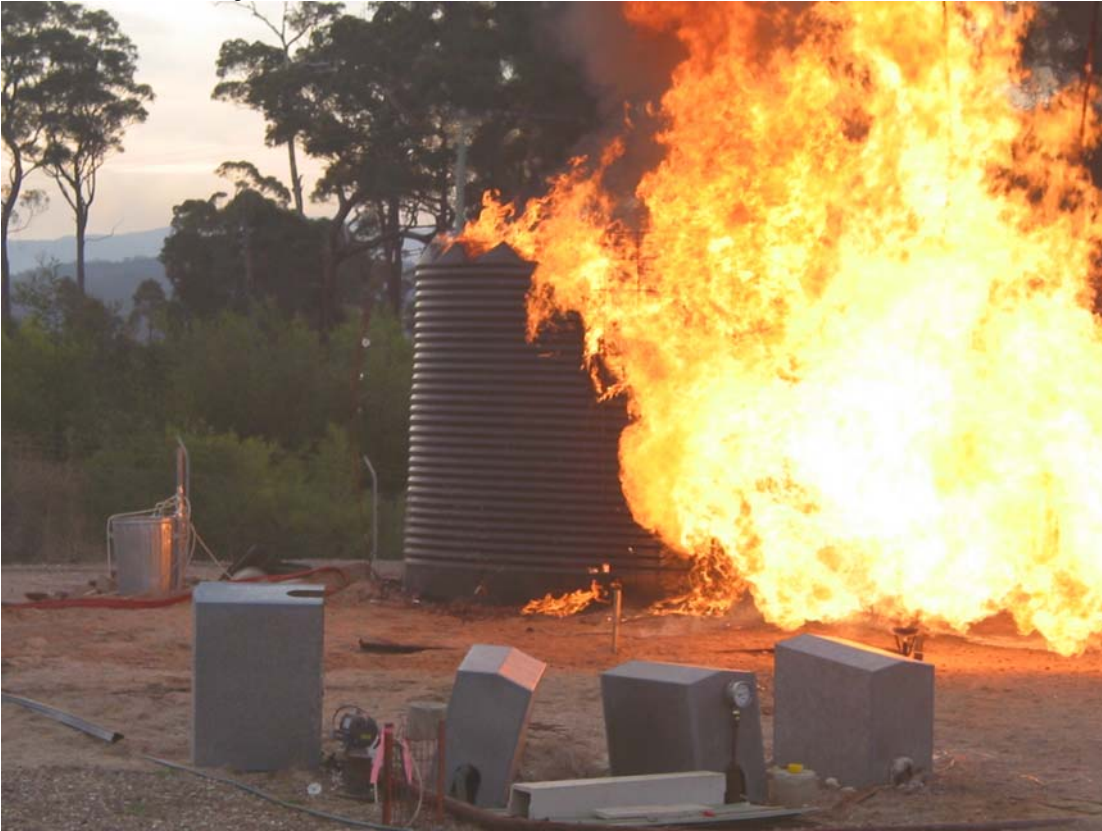
Figure C52 Tank 8 ignition due to structural fire exposure.

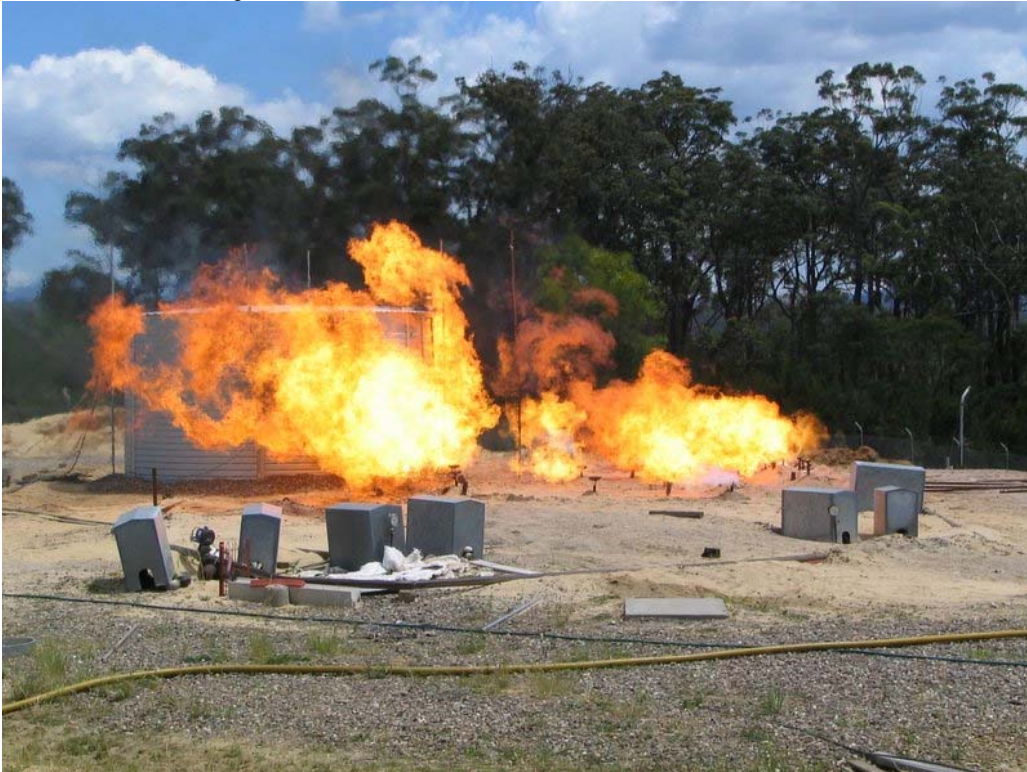
Figure C60 Bladder tank pre-radiation and flame exposure.

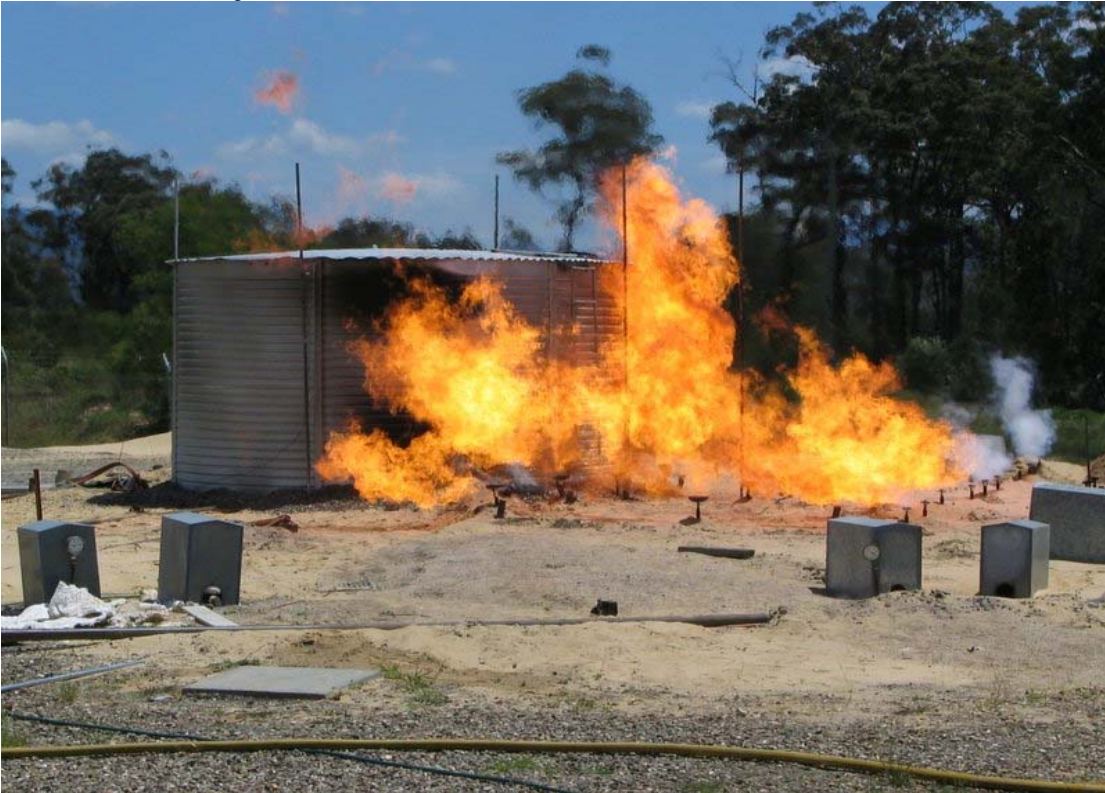
Figure C64 Tank 9, bladder tank structural exposure.

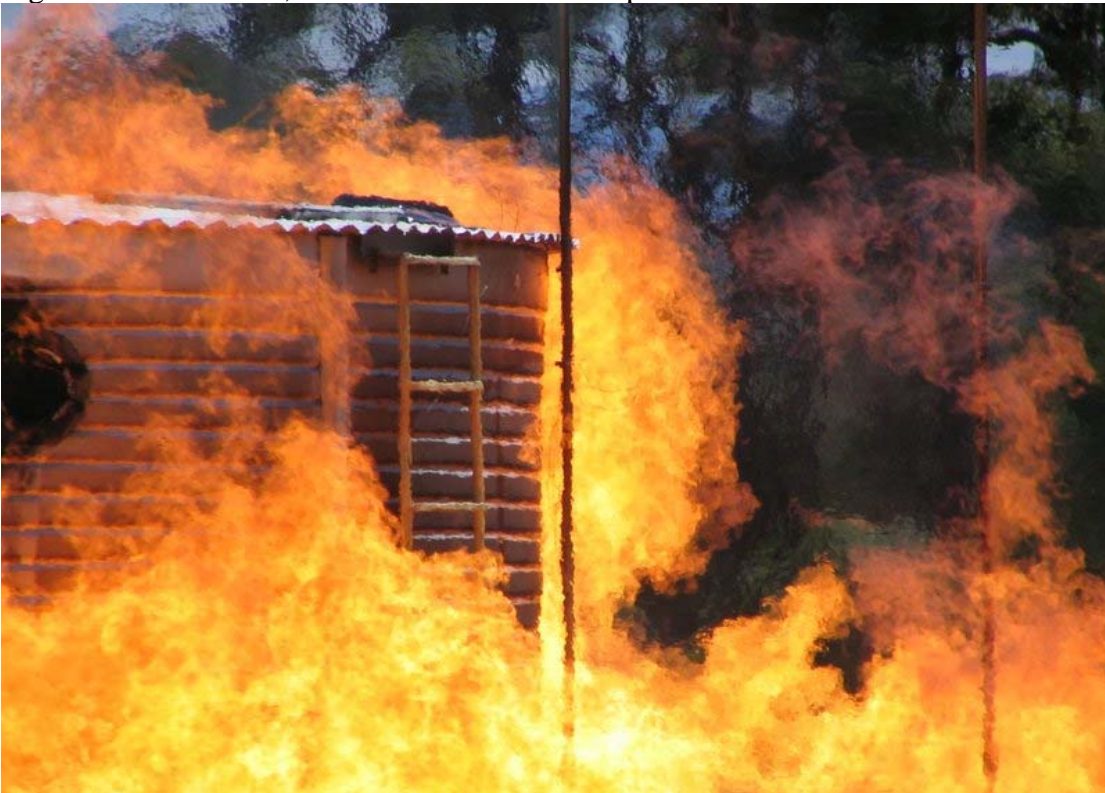
Figure C65 Tank 9, the bladder tank structural exposure.
