→ Tanks on trial for home defence

A Bushfire CRC project has assessed the performance of rainwater tanks in bushfire conditions

The research was conducted as part of Bushfire CRC project D1 Protecting People and Property.

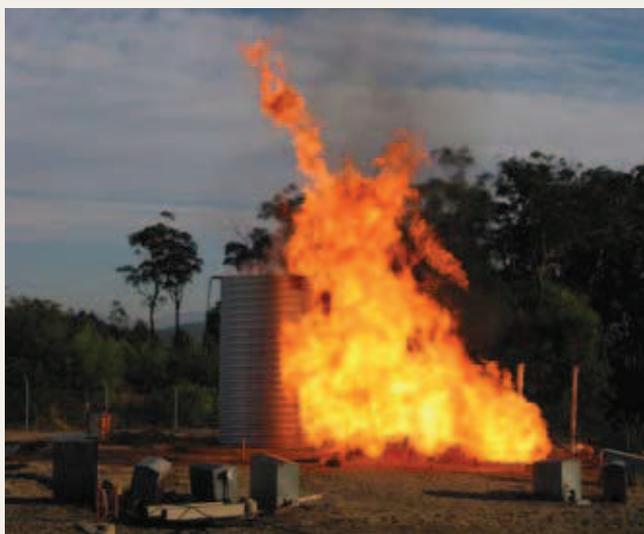
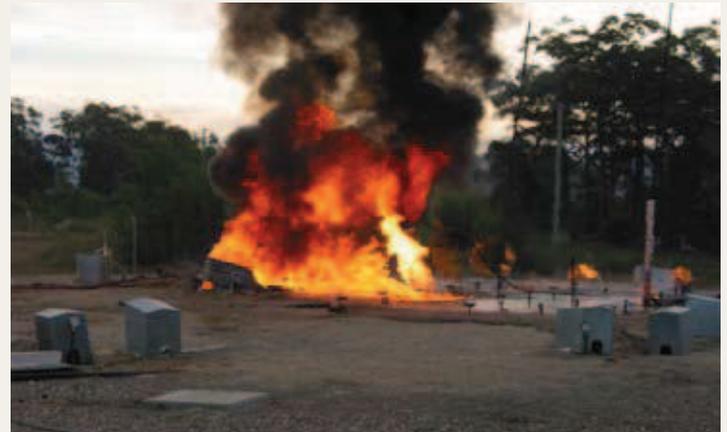
▲ ABOVE AND TOP RIGHT: RAINWATER TANKS WERE TESTED UNDER SIMULATED BUSH-FIRE CONDITIONS AT THE RFS TEST FACILITY AT MOGO.

Of the different materials tested, spiral wound, steel tanks performed best under all exposure conditions. All steel manufactured tanks maintained structural integrity when faced with a 30 minute flame immersion test, simulating an adjacent structural fire.

Steel construction bladder tanks maintained structural integrity during all tests. The bladder construction proved able to retain water during and after the fire-front, which is critical for the protection of property and assets in the event of a bushfire.

Polyethylene tanks demonstrated structural deformation during the 30 minute flame exposure, resulting in the tank splitting itself and melting down. Polyethylene tanks were at risk of total failure when adjacent combustible items are present, such as forest litter, fences or other polyethylene tanks.
