**RESEARCH INTO THE PERFORMANCE OF
WATER TANKS IN BUSHFIRE
-Bushfire CRC Project D1**

**R. Blanchi, J.E. Leonard, N. White, A. Sargeant, A. Bicknell, S Andersson
CSIRO – Sustainable Ecosystems (CSE)
Urban Systems Program**

USP2007/014

December 2007

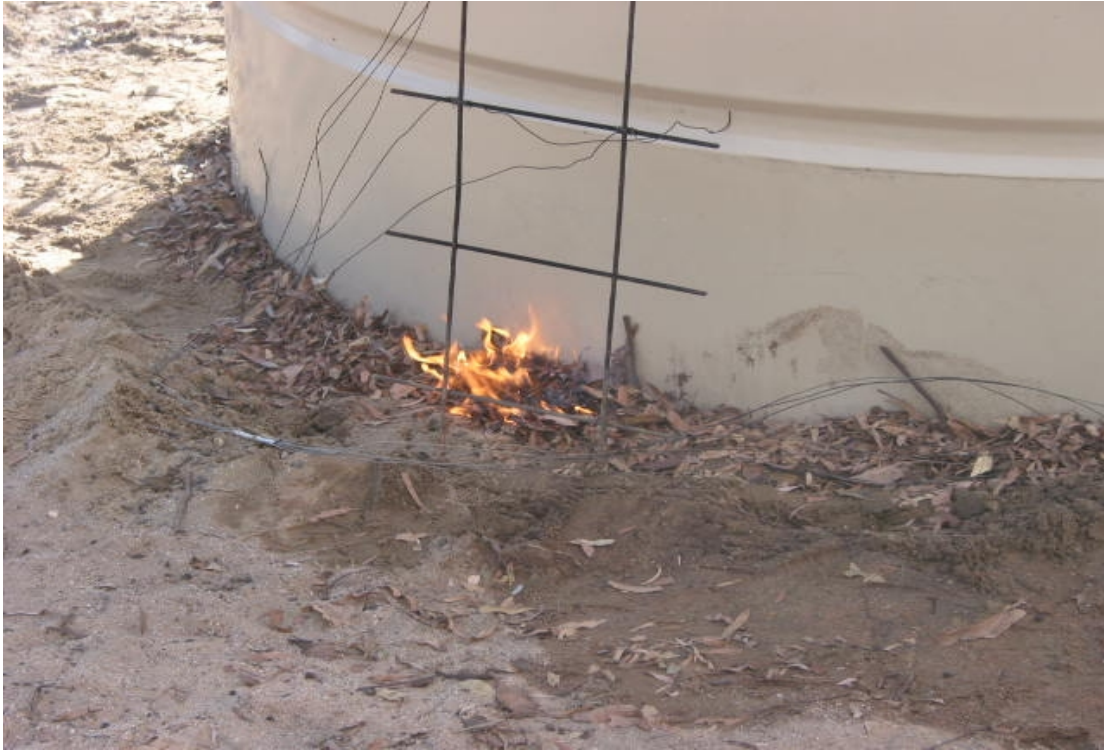
Figure C7 Tank six Litter ignition.

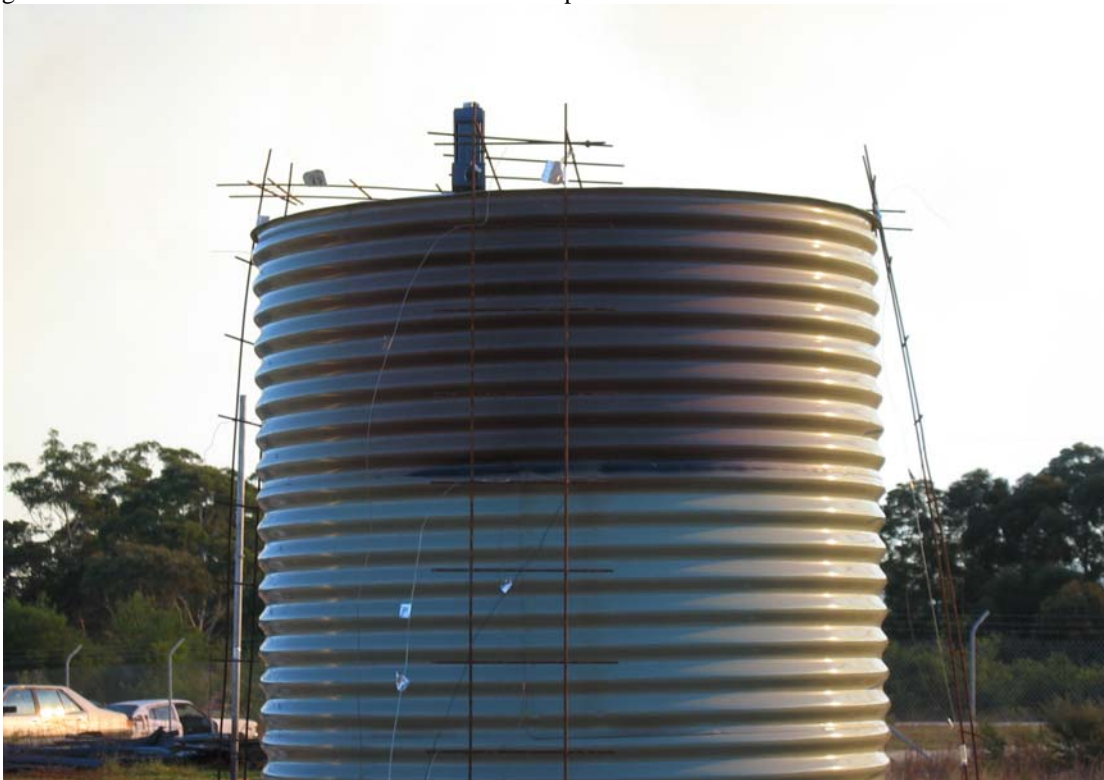
Figure C15 Tank three scorch mark above the water line.

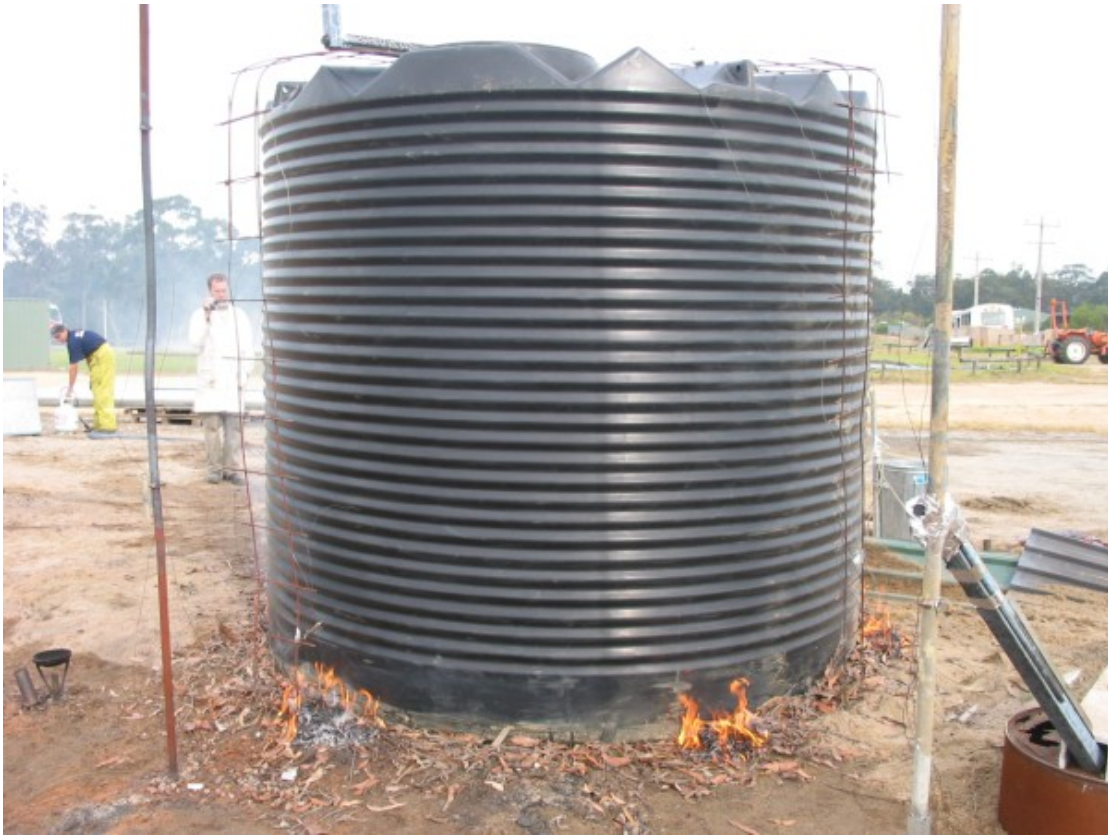
Figure C42 Tank 8 litter ignition .
